RAPID BAY JETTY

STRUCTURAL CONDITION REPORT

FINAL REPORT

December 2004

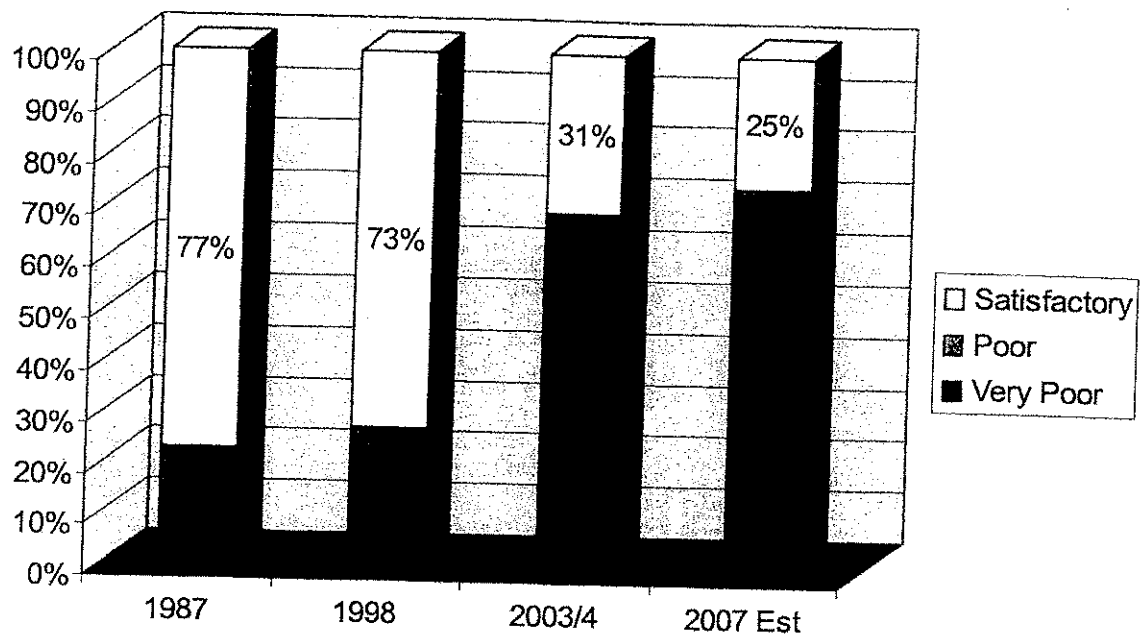
Figure 3.1 –Breakdown of Pile Condition – All Piles from Bent 27 to 79

Table 3.1 highlights that the condition of the piles has decreased rapidly between 1998 and 2003/4. By extrapolation of individual pile condition to 2007, a rapid shift from satisfactory into the poor and very poor categories is predicted. This rapid deterioration is graphically represented in Figure 3.1 below.

This deterioration rate is of concern given that all timber piles between bents 27 and 79 were recommended for replacement as far back as 1992 and it is obvious that further deterioration has occurred since this time.

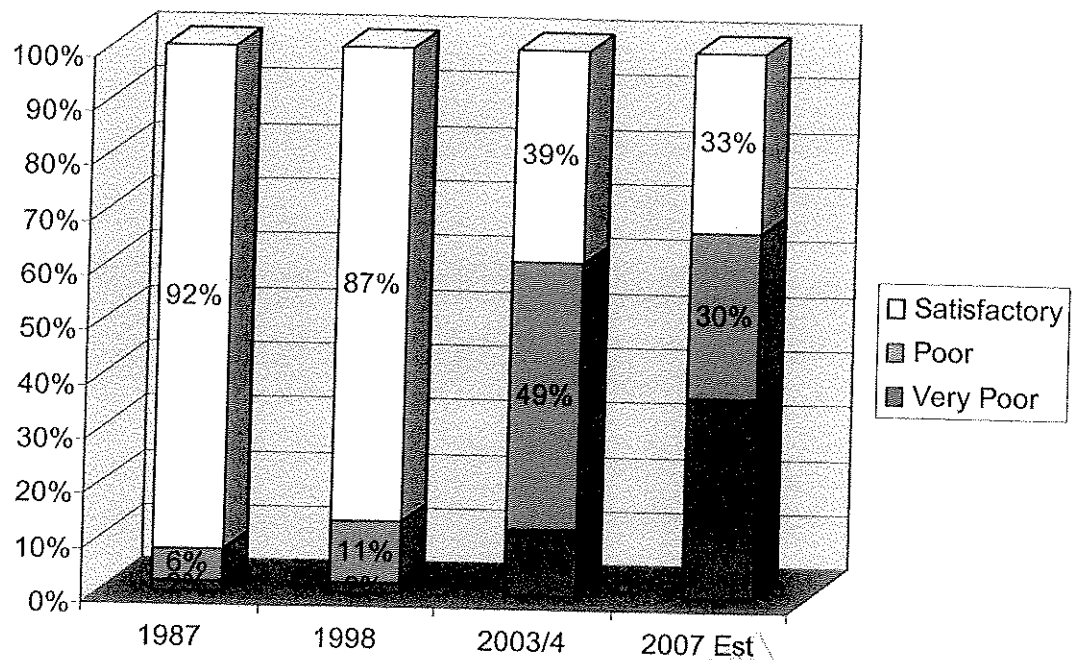
Figure 3.2 –Breakdown of Pile Condition – Central and Eastern Piles Only from Bent 27 to 79

Figure 3.2 indicates that if the western piles are ignored, there will still be more than two thirds of the remaining piles in a poor or very poor condition by 2007.

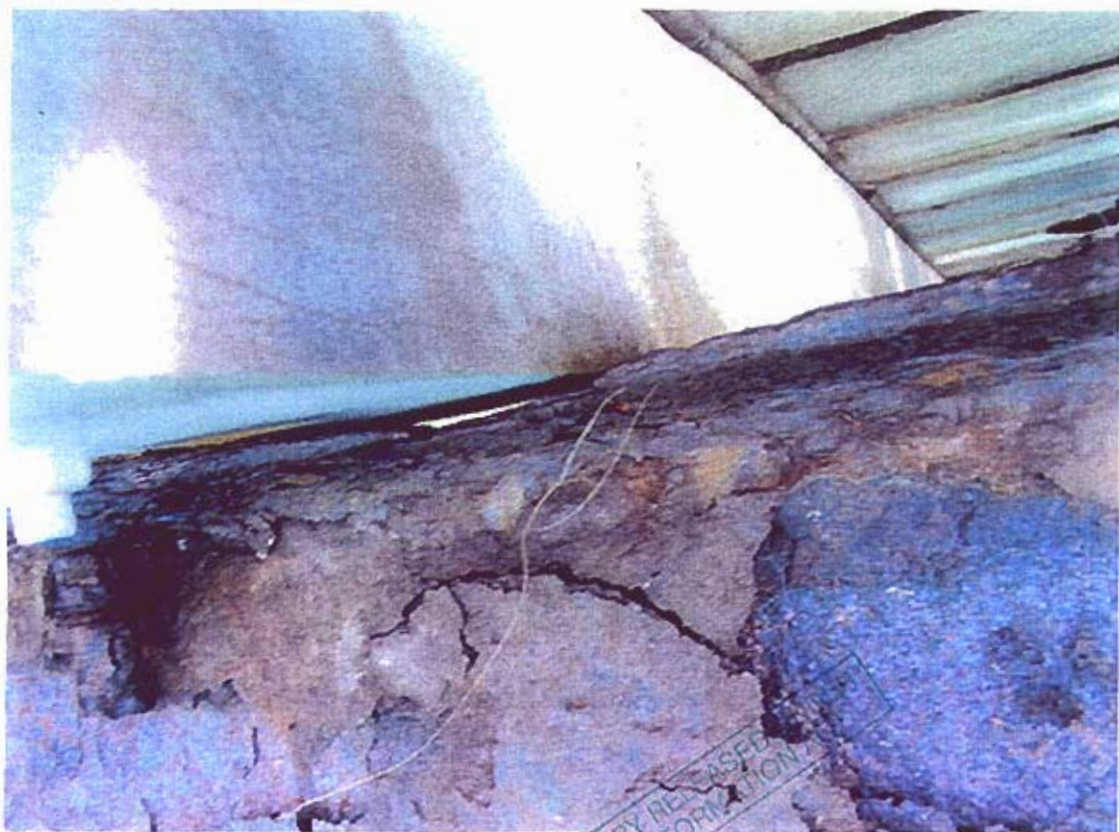
The steelwork on bents 11 to 75 ranges from poor to very poor with substantial amounts of flaking and delamination corrosion resulting in large amounts of section loss with holes in both the webs and flanges of the girders not uncommon (photos 6-10, 12). The steelwork on the western side that previously supported the conveyor system and is exposed (ie, does not support decking) is in very poor condition. There are numerous corrosion holes in the both the girders and bracing, with a number of bracing connections having failed (photos 11, 13). Likewise the steelwork supporting the timber decking is in very poor condition. It is important to note that the original design incorporated extra thickness sections to act as a corrosion allowance. Although no definitive measurements have been undertaken in this review, the level of corrosion is much greater than the initial corrosion allowance and generally appears greater than 50% of section.

Photo 6 – Hole in Girder Top Flange

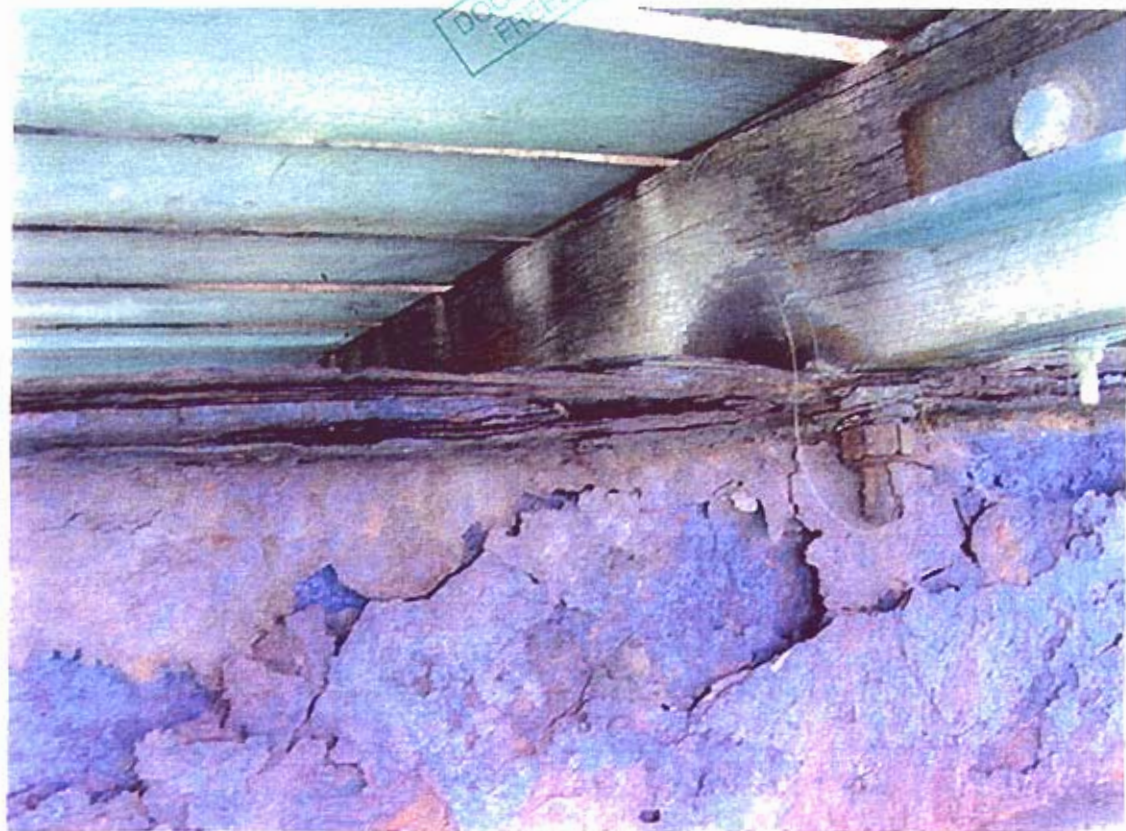
Photo 7 – Jacking Corrosion of Girder Top Flange

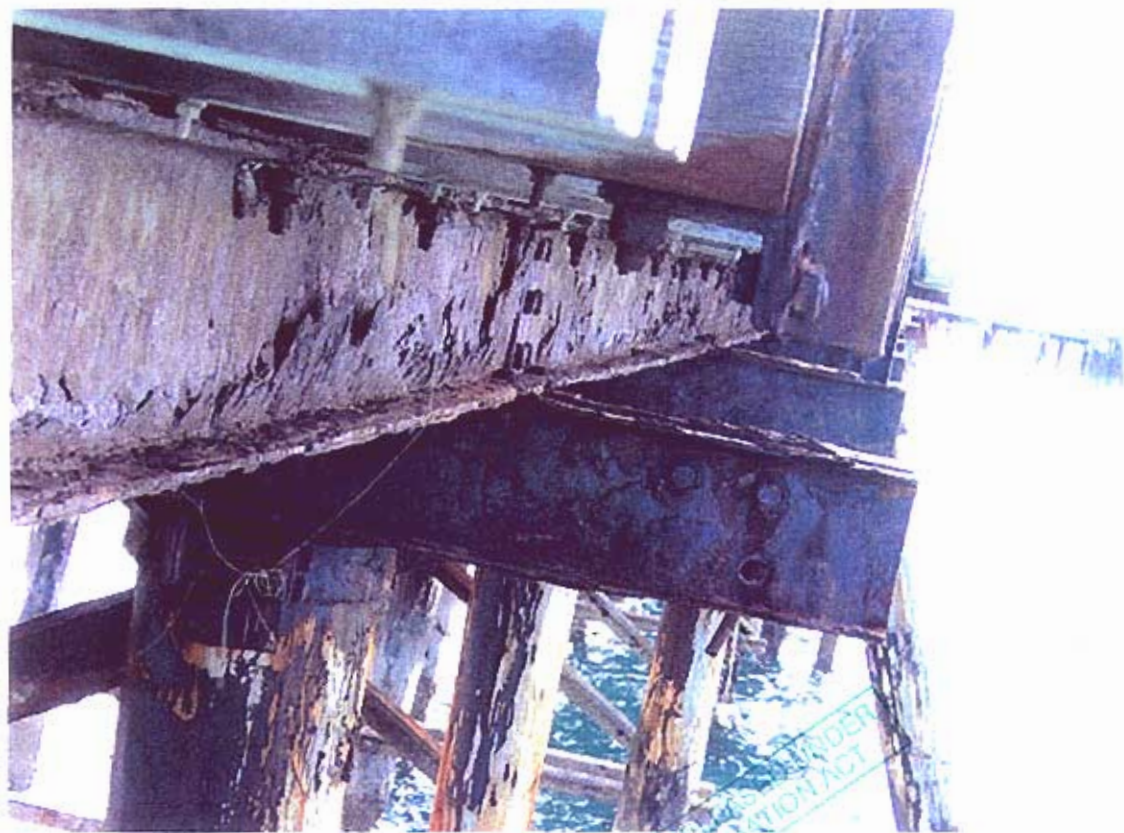
Photo 8 – Typical Girder Corrosion

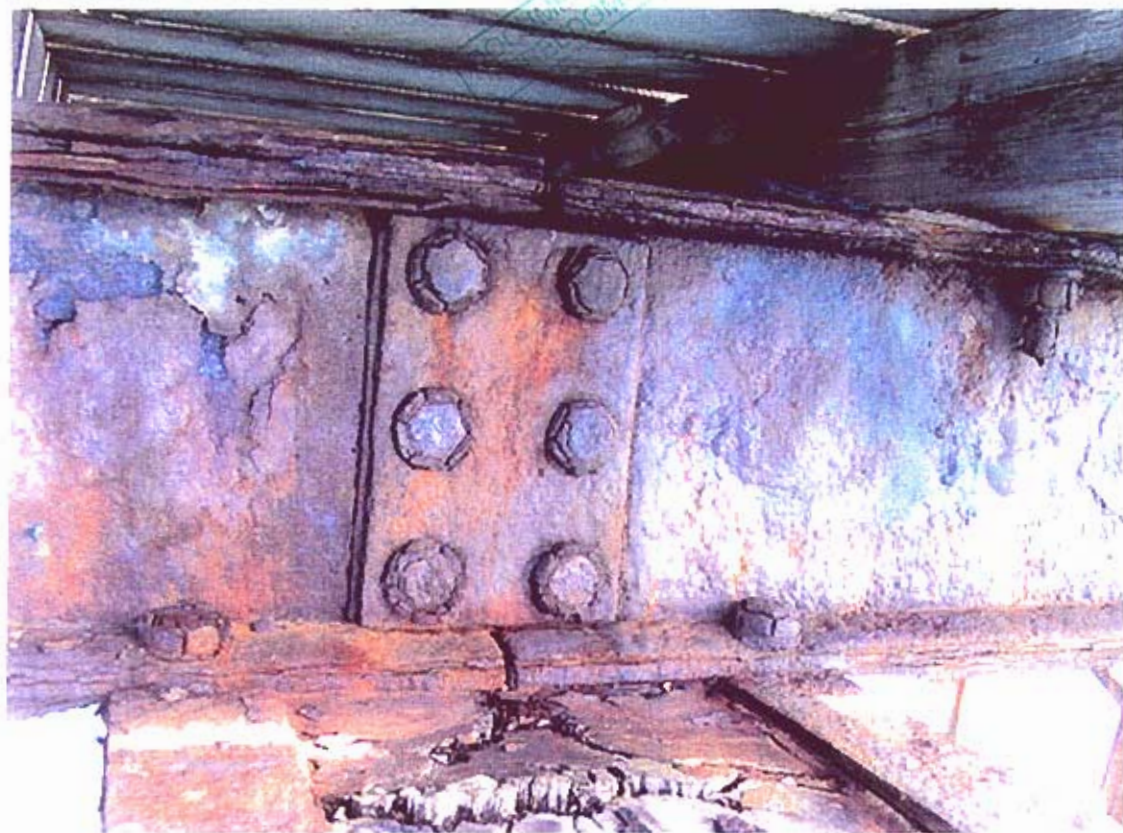
Photo 9 – Typical Girder Corrosion

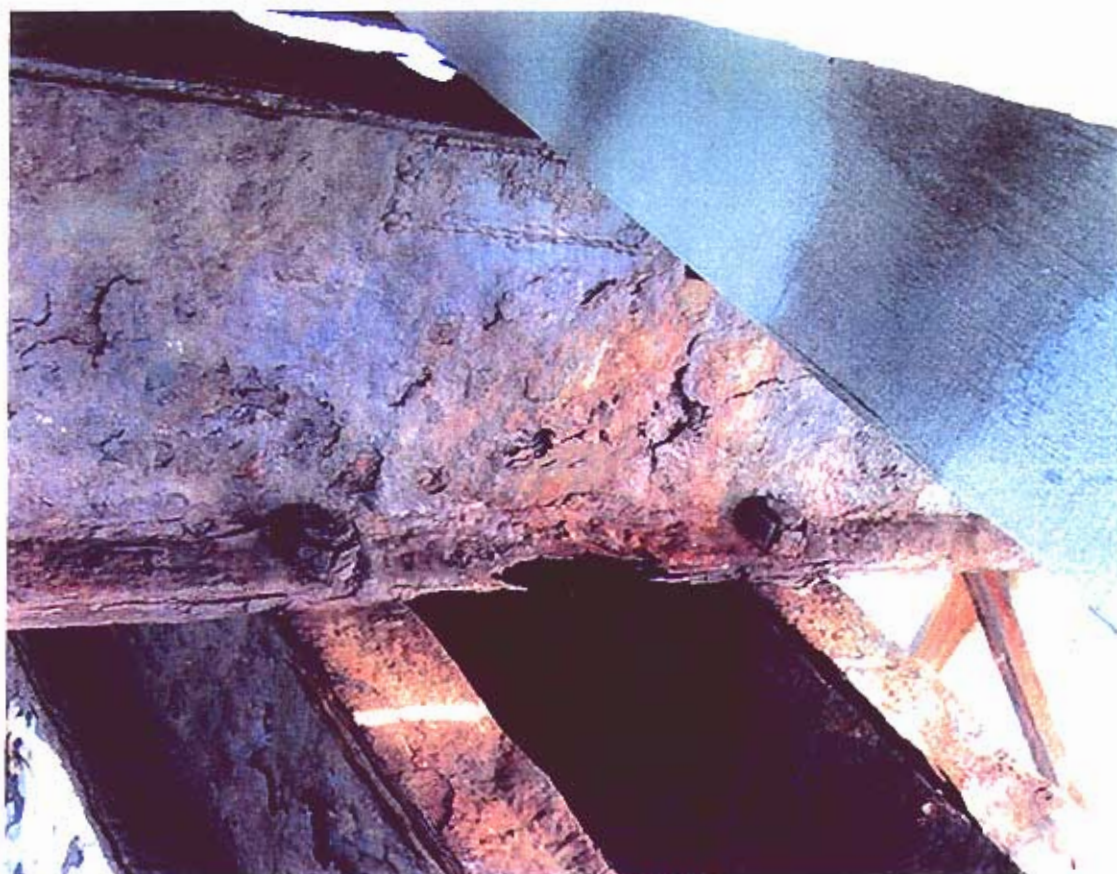
Photo 10 – Girder Corrosion – Hole in Bottom Flange

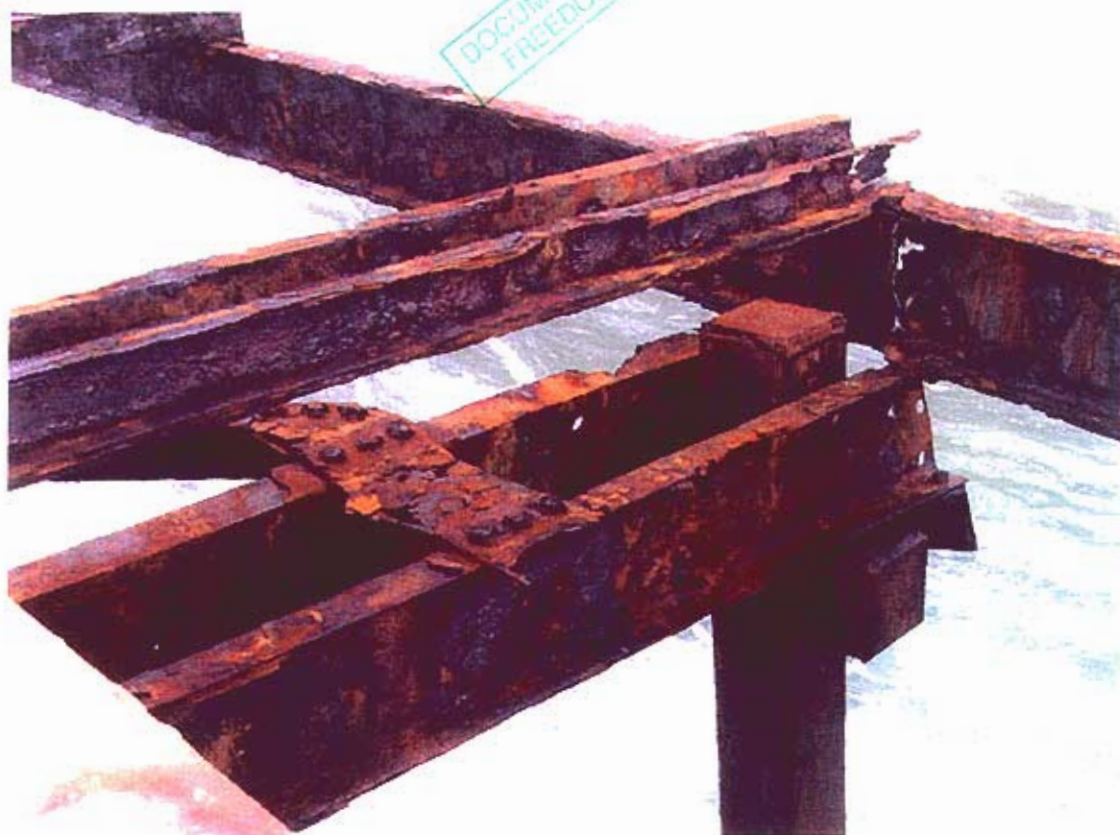
Photo 11 – Steelwork Corrosion, Bent 16 - Western Side

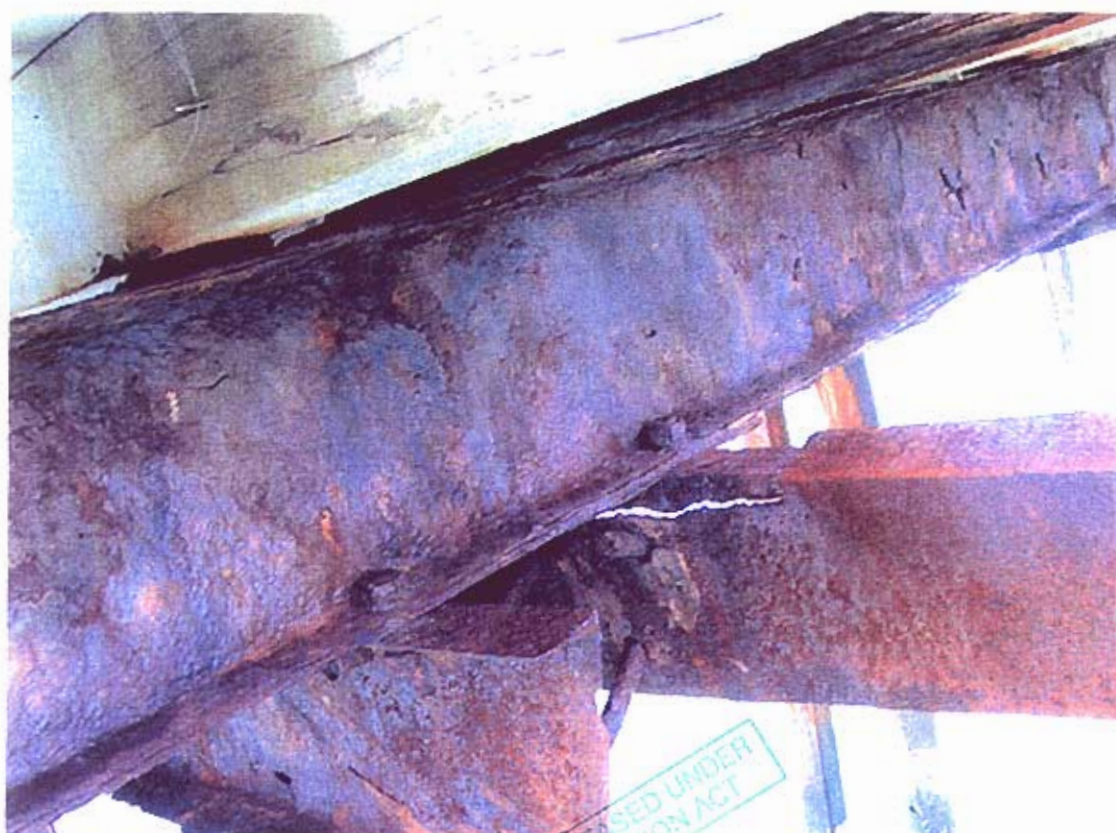
The steel crossheads are heavily corroded with large areas of flaking corrosion and section loss. Holes in the webs and flanges of the crossheads are not uncommon (photo 12).

Photo 12 - Hole in Crosshead Web – Bent 19, Western Side

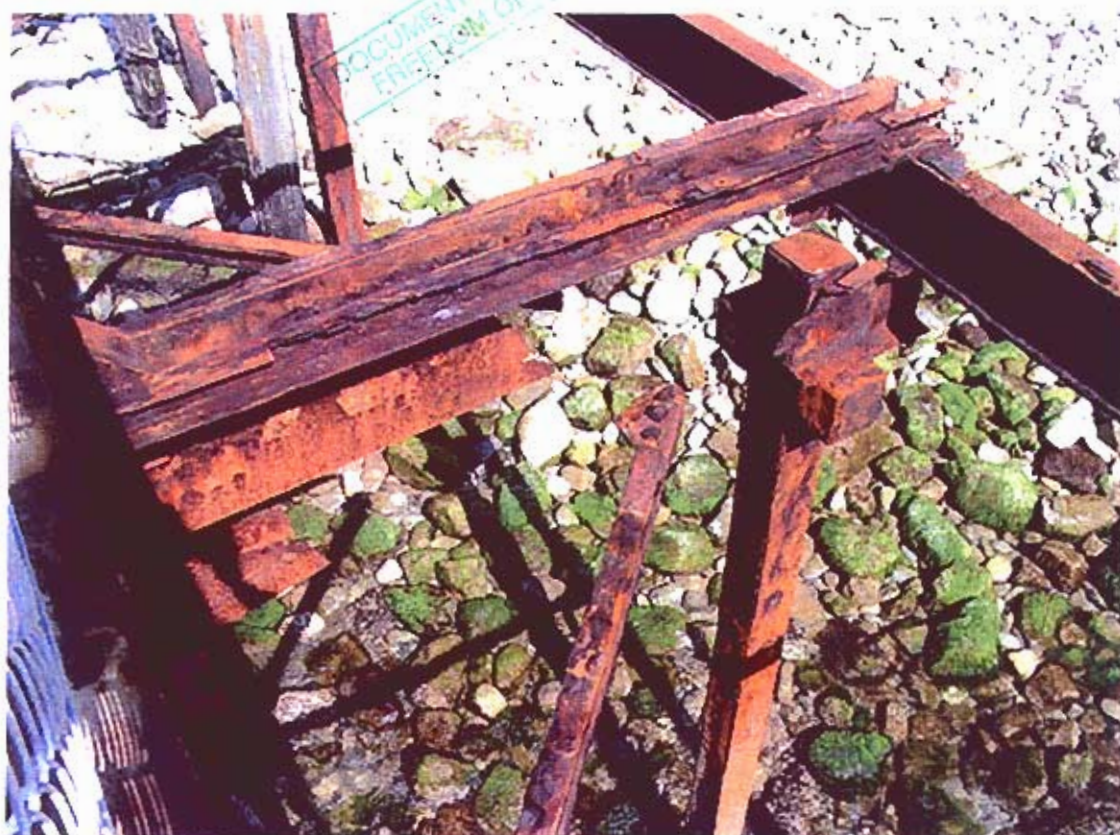
The original timber piles from bents 27 to 79 are in a very poor condition with numerous heavily necked piles, especially at bents 28, 29, 41 and 42 (photos 14-19). The piles on the western side of the structure are generally the worst as the swell predominantly comes from a north-westerly direction (see Location Plan, Appendix A). A number of piles on the western side have necked to the extent that they have broken off and now "hang" from the superstructure steelwork. These 'hanging' piles are supported by the girders spanning between two bents and by the steel crosshead cantilevering from the central pile. At bents 11 and 15 the wave action acting on the "hanging" pile on the western side has resulted in the pile twisting and breaking the twin steel channel crosshead and falling off (photo 13). It is

Photo 13 – Pile Missing, Crosshead Broken – Bent 11, Western side

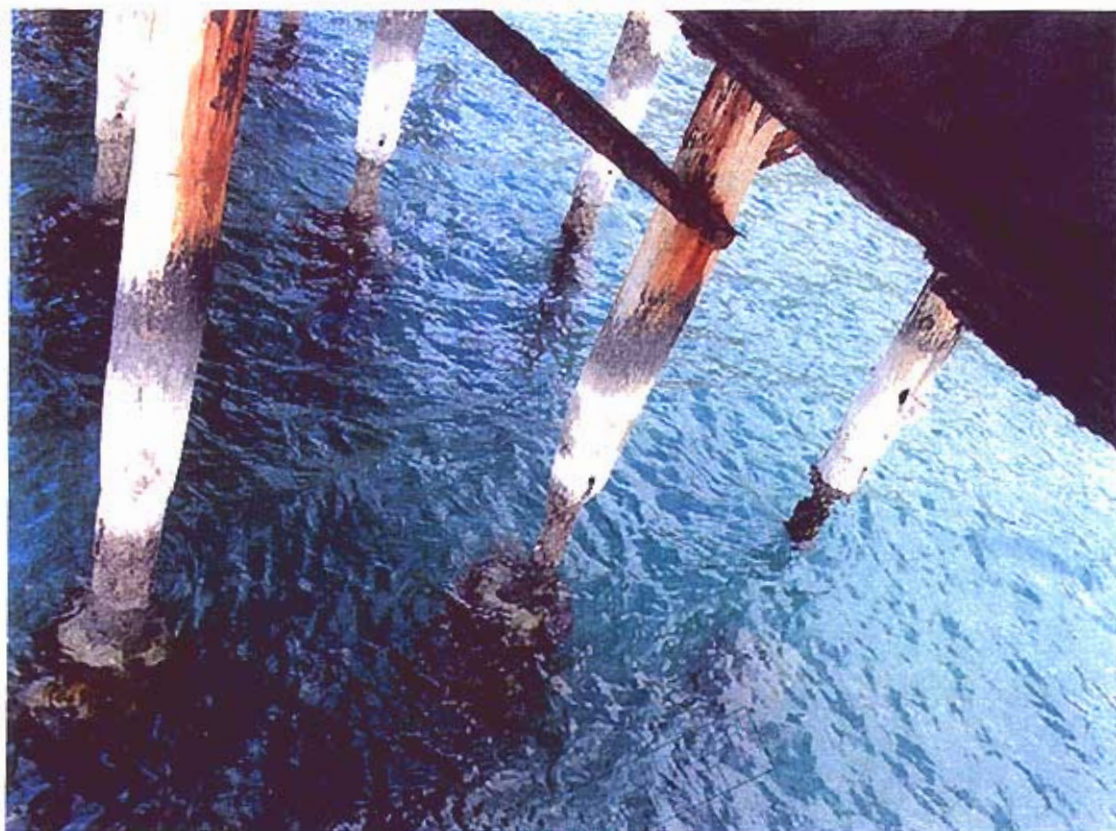
Photo 14 – Typical Pile "Necking"

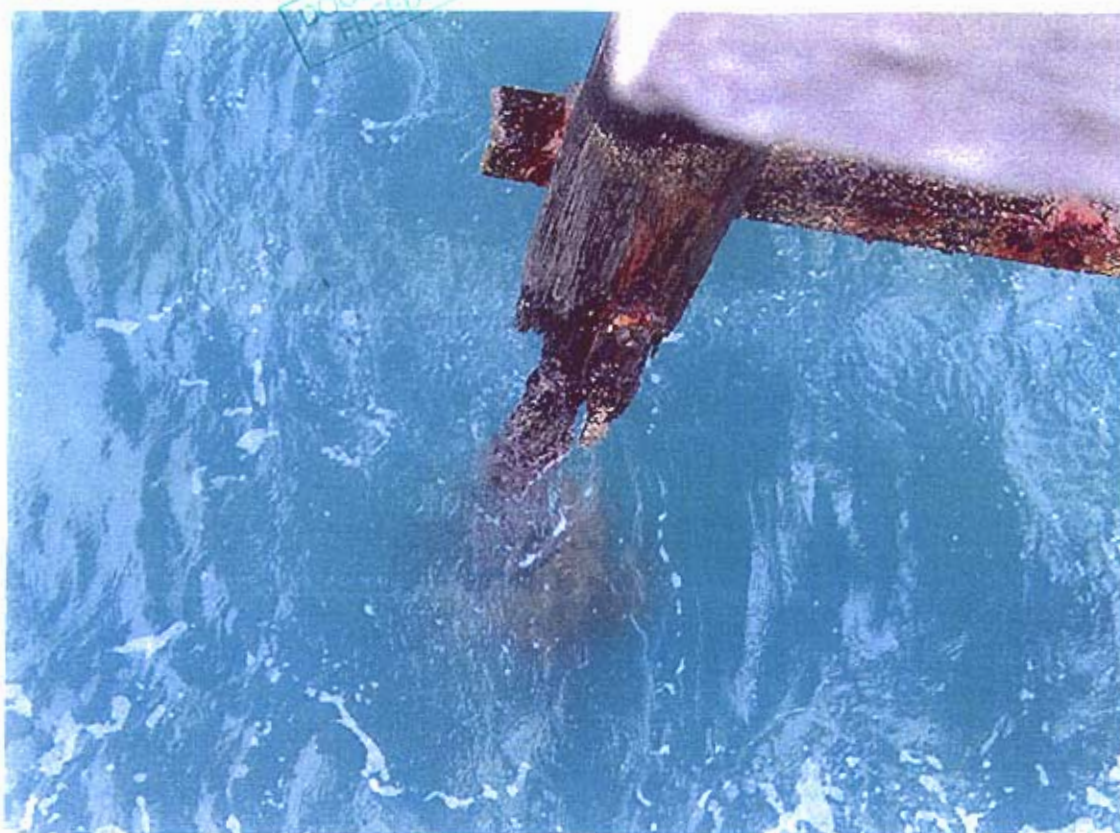
Photo 15 – Heavy Pile "Necking" – Bent 47, Eastern Side

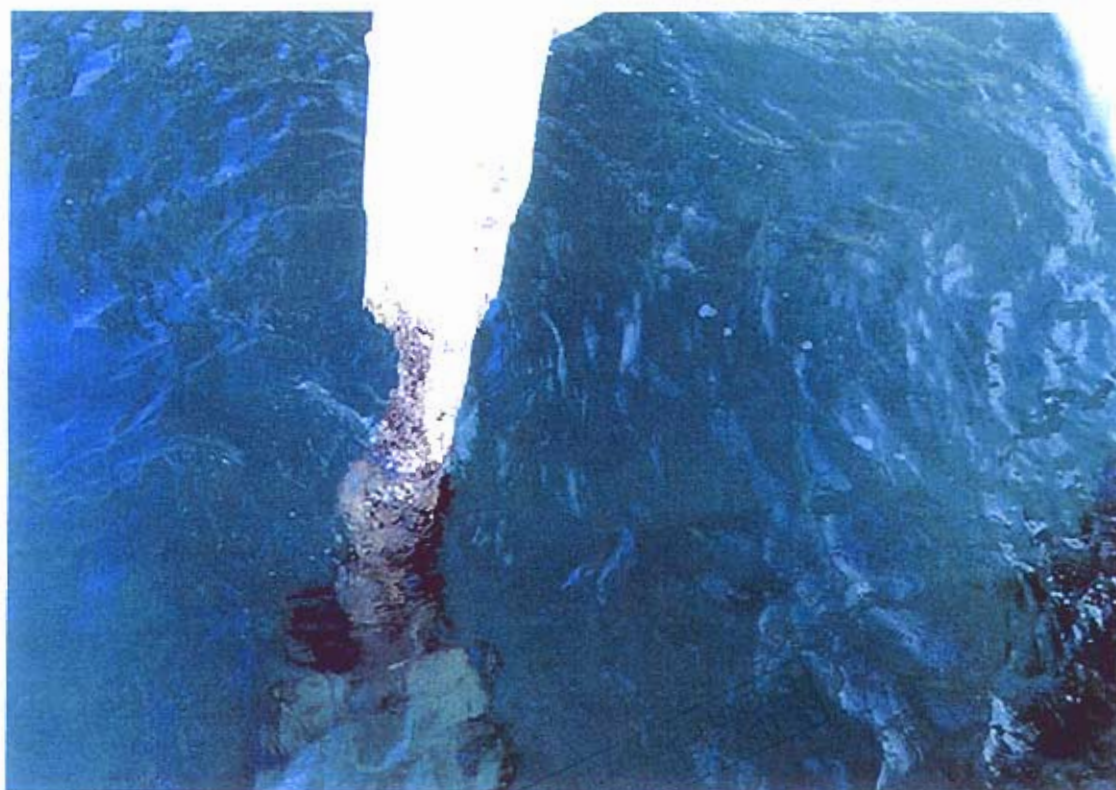
Photo 16 – Heavy Pile "Necking" – Bent 47, Eastern Side

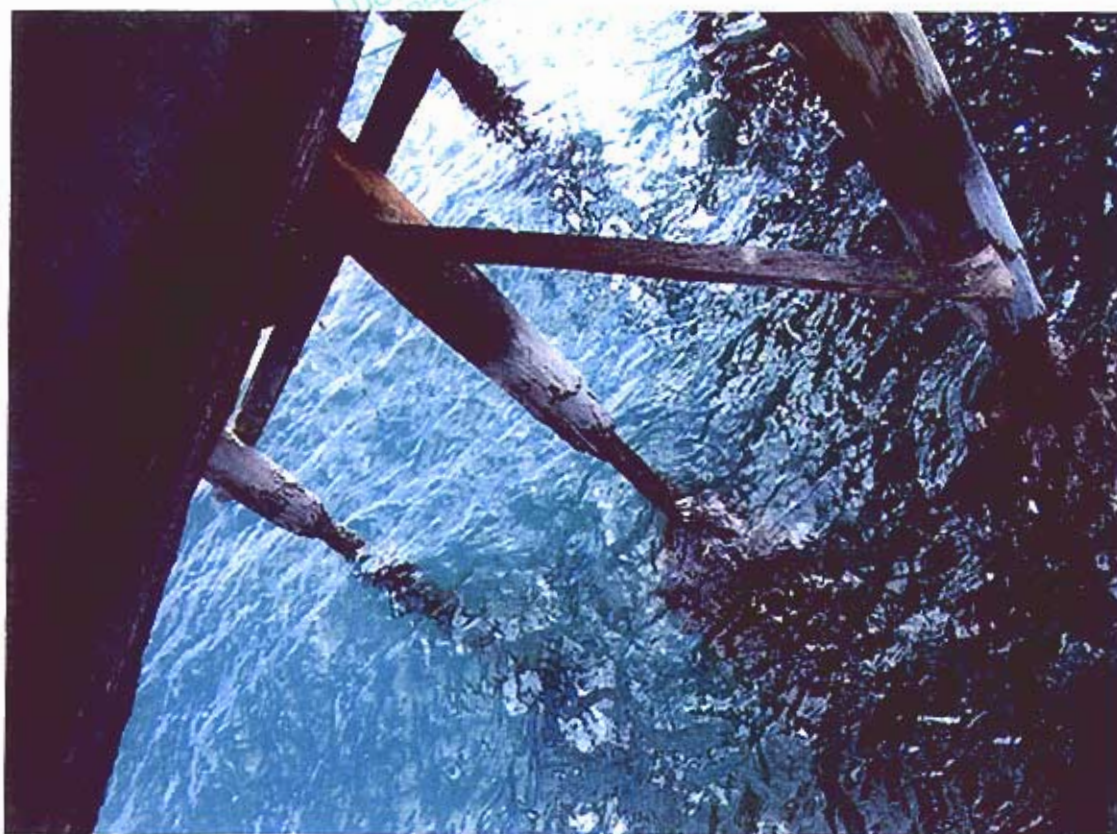
Photo 17 – Pile "Necking" – Bent 46

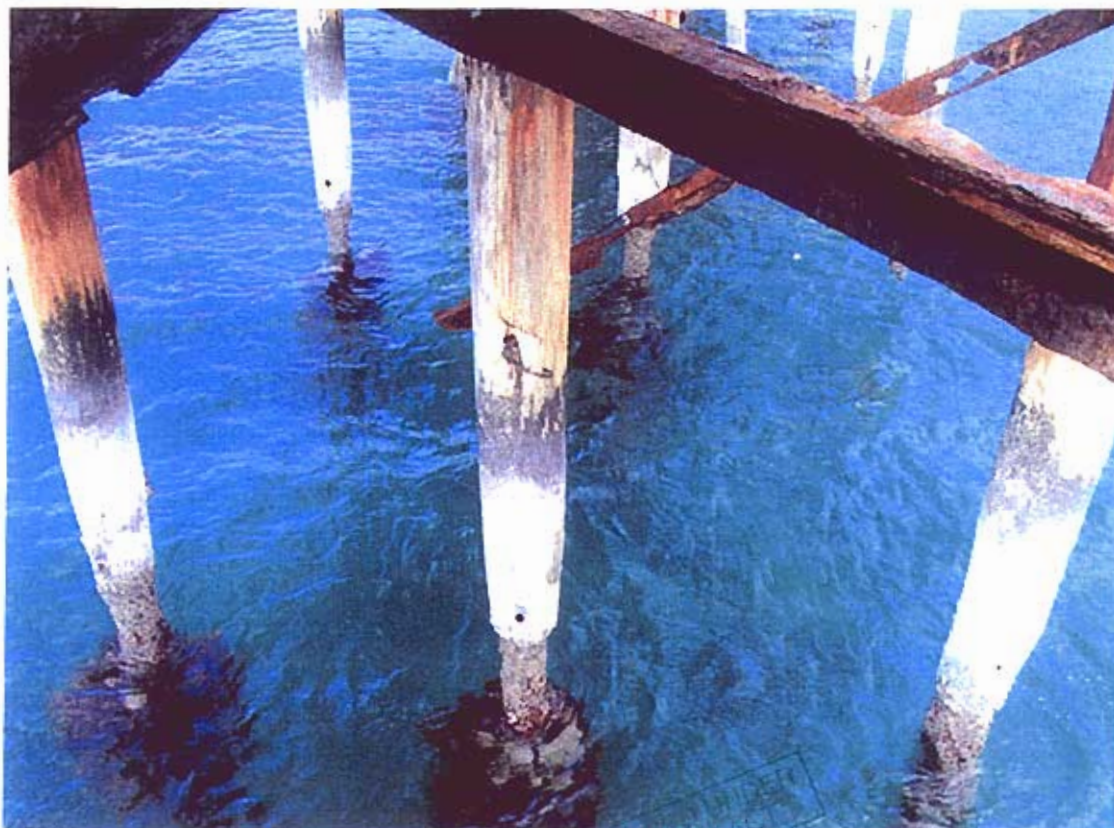
Photo 18 – Typical Pile "Necking"

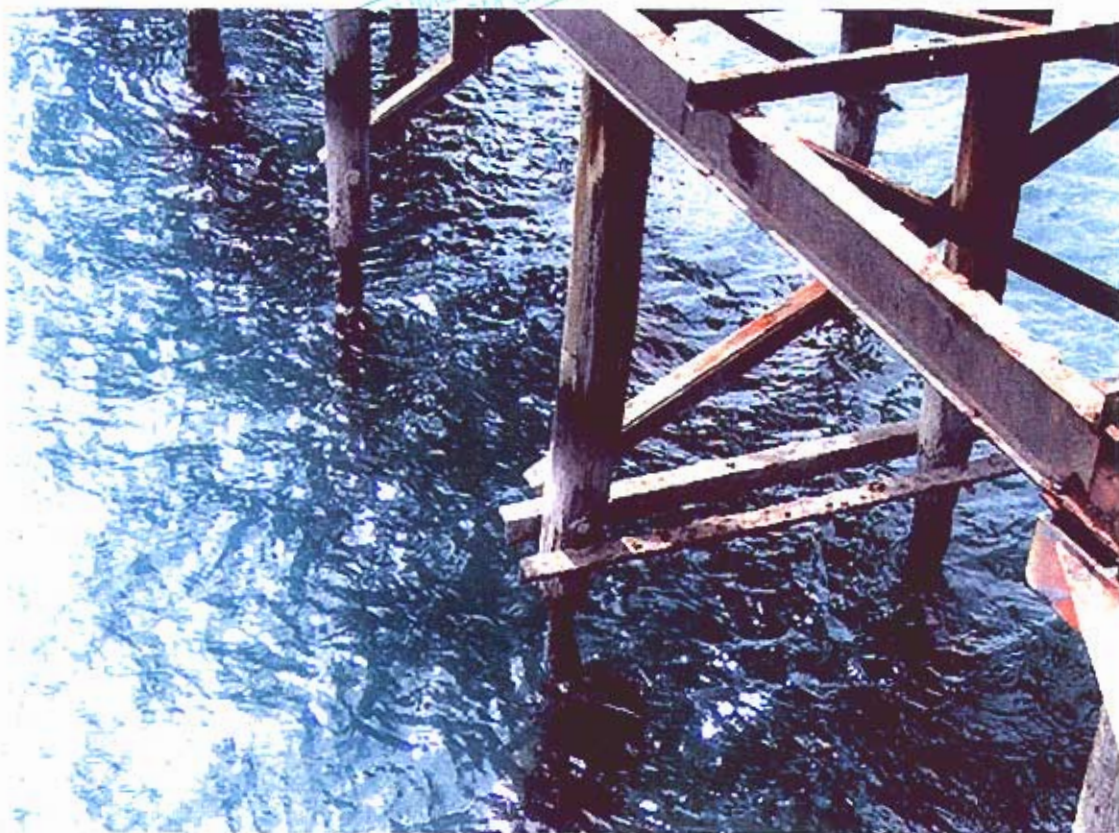
Photo 19 – Typical Pile "Necking" – Bents 40 & 41

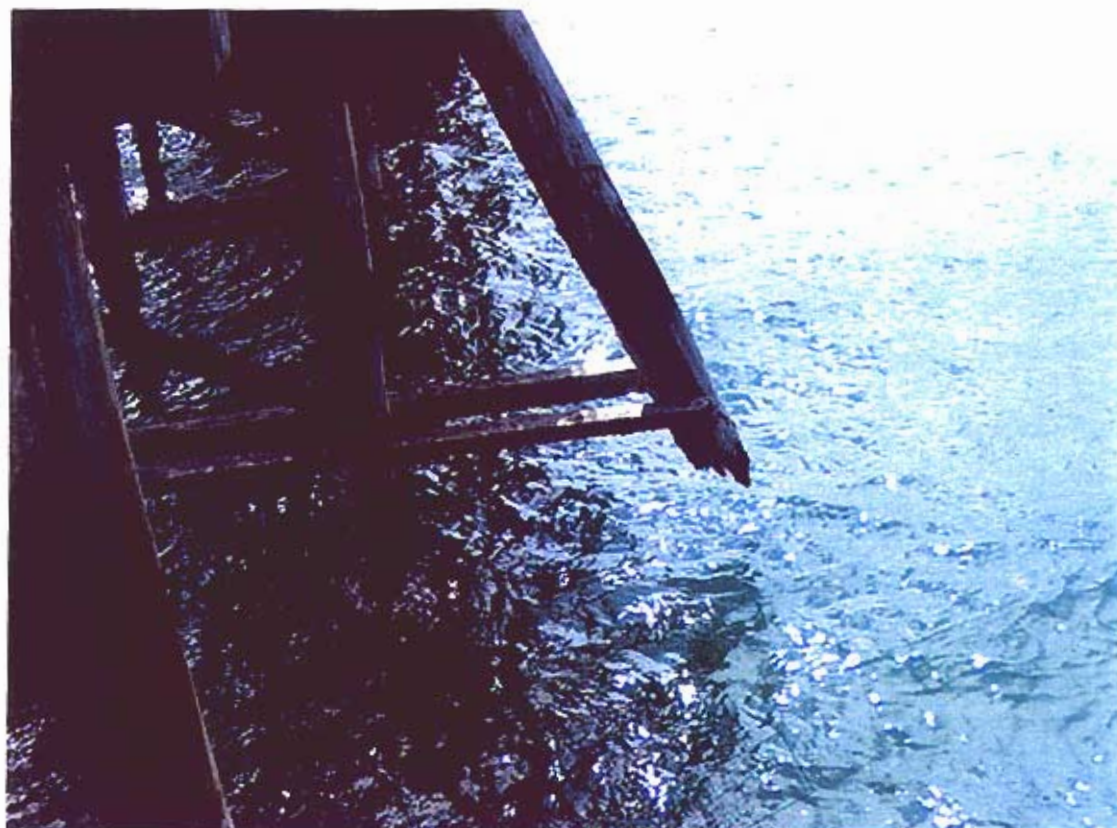
Photo 20 – Broken Raking Pile, Bent 64, Eastern side

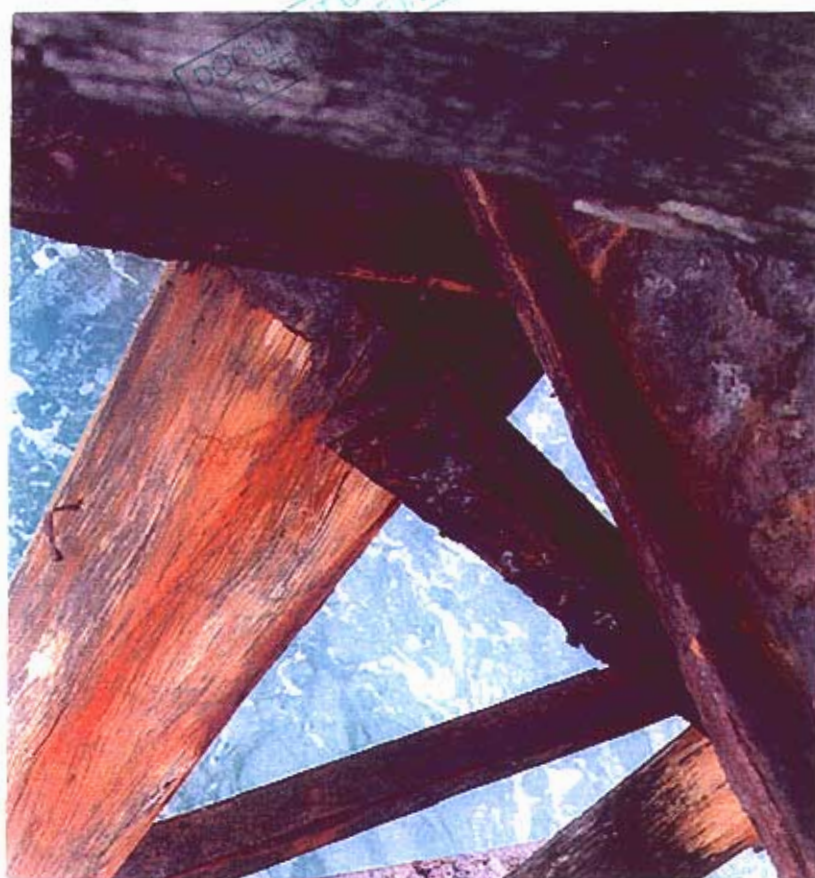
Photo 21 – Typical Bracing Corrosion
