Transport SA

Rapid Bay Jetty

Structural Assessment Report

June 1998

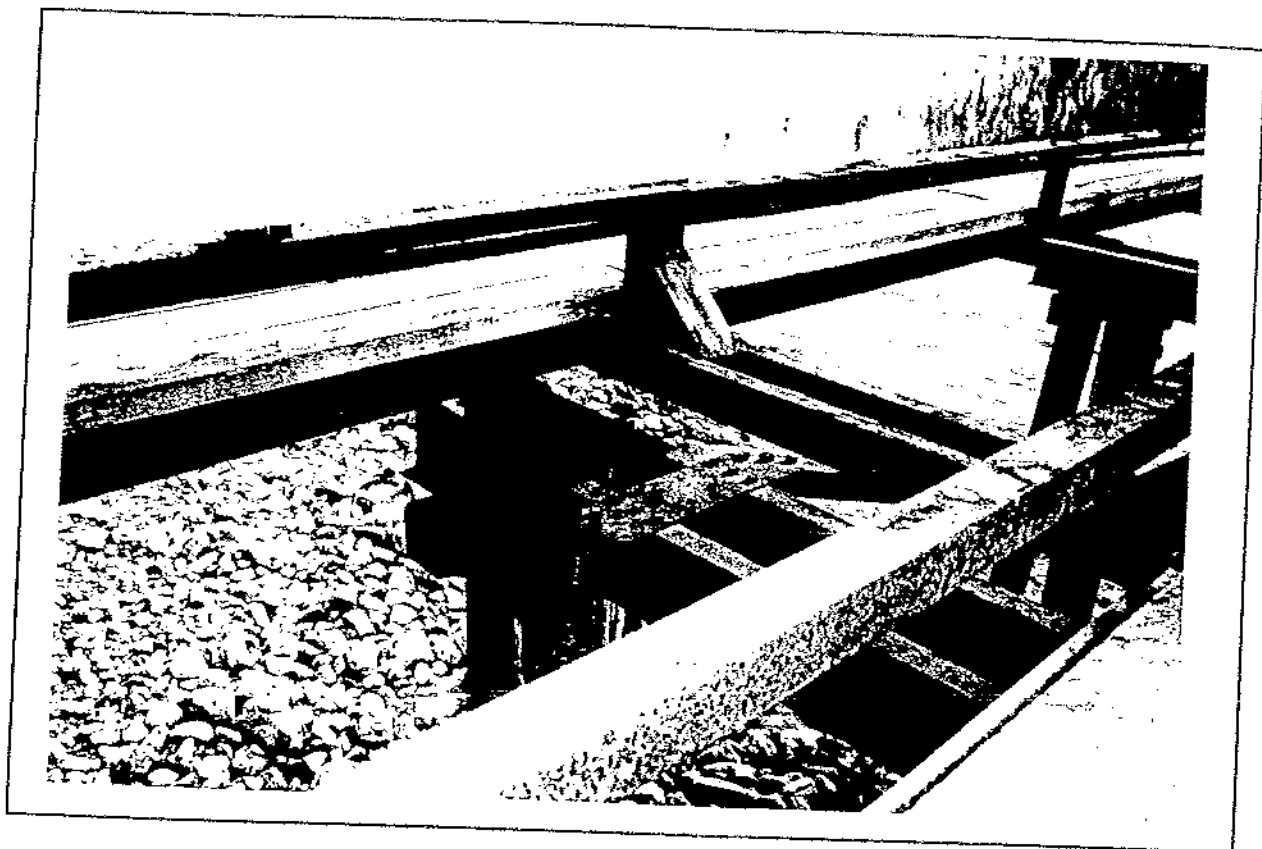
9. Crosshead Bent 9

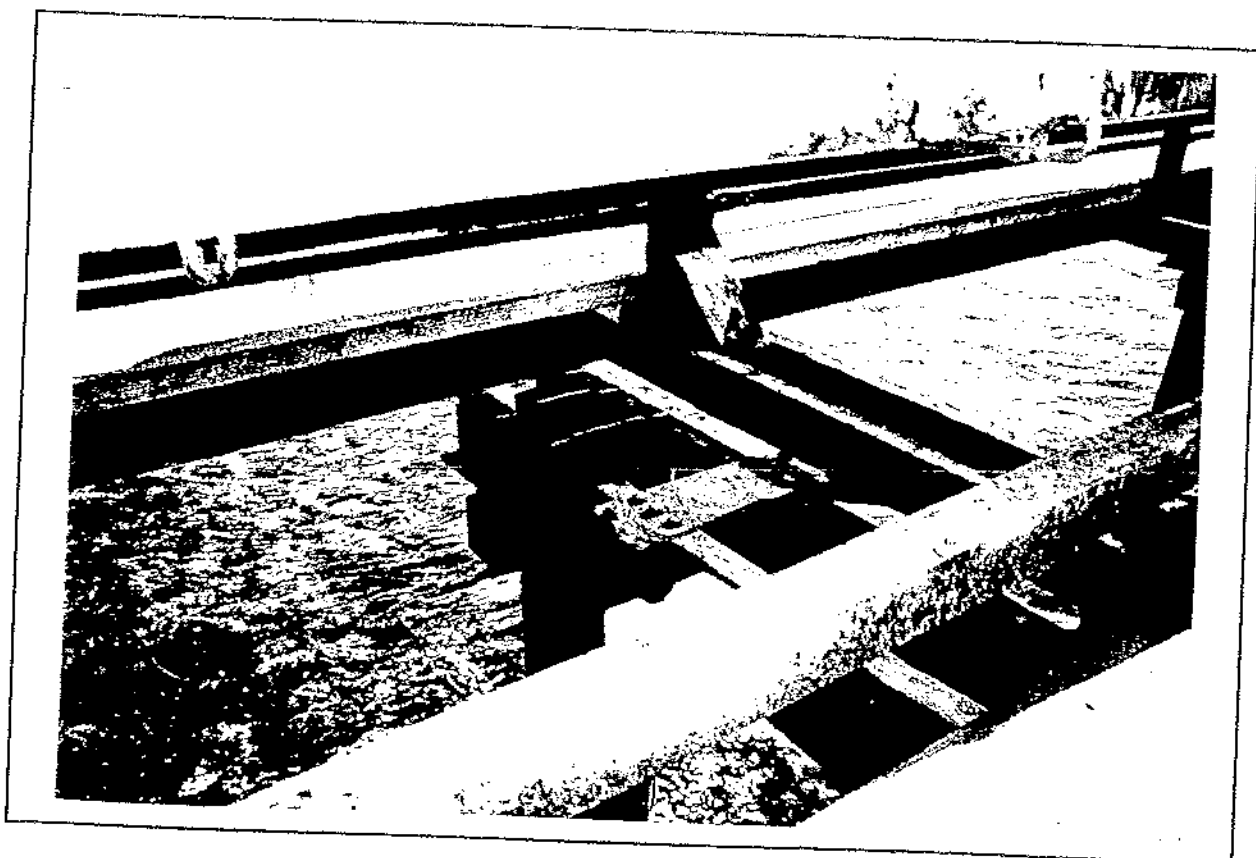
10. Crosshead Bent 12

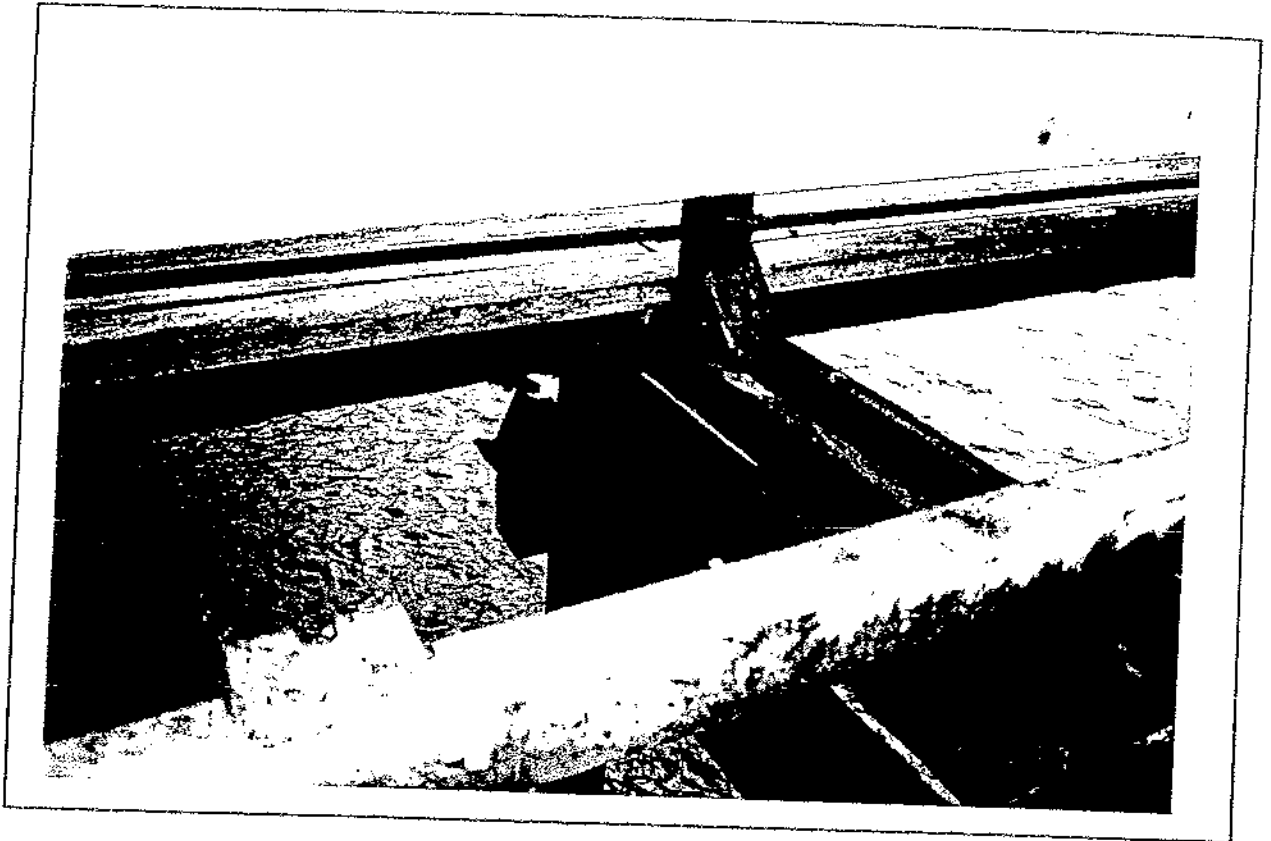
It is common that the flange thicknesses of stringers and crossheads appear to be reduced to less than half of their original dimensions. At Bent 17, in particular, the seriously corroded crossheads are twisted with the western stringer detached although the neighbouring structure is still in serviceable condition.

- 17 → v poor Cross Head Condition

11. Crosshead Bent 17

12. Crosshead Bent 17

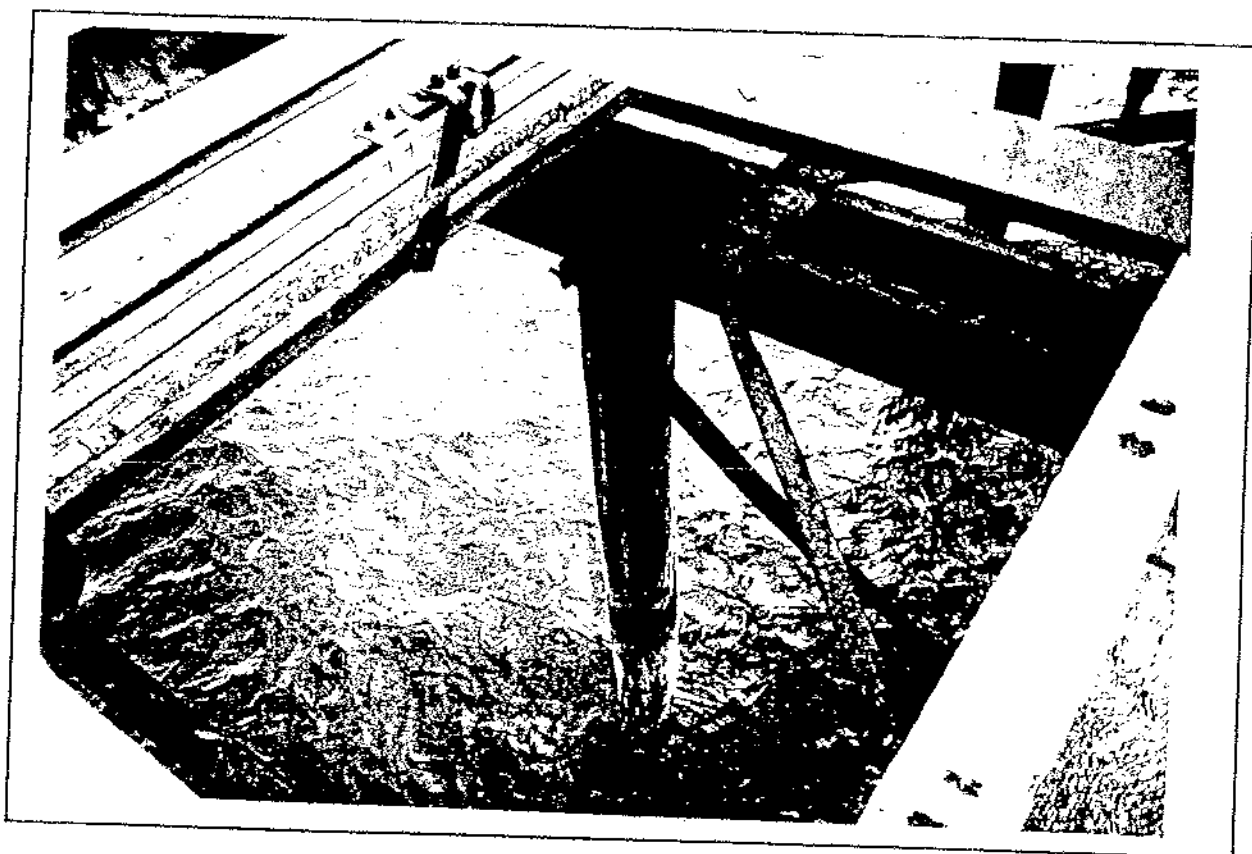
In several locations, eg Bents 27 and 32, the pile bent provides no support to the stringers because of pile failure. The stringers are therefore spanning across two bays, ie 9.35 m.

(NB Very poor condition
at Bents 27 & 32)

14. Pile at Bent 27

1. **Accept as is** - this limits the load to a 2 tonne axle load.
2. Replace the 9.35 long stringers with two new 310 UB 46.2 beams in the line of the wheels. This would increase the stringer allowable wheel load to 3.1 tonne.
3. Repair the broken piles which would restore the 4.5 m span and raise the stringer limit to 4.5 t (see 3.2(b) above). Vertical steel straps bolted to the sound pile sections could be used.

The 2.2 tonne limit imposed by degraded piles at some locations could be increased to 6.5 tonne by an increase of equivalent cross sectional diameter to 250 mm. This could be achieved by repair of the piles as described in Alternative 3 in 4.1 above.

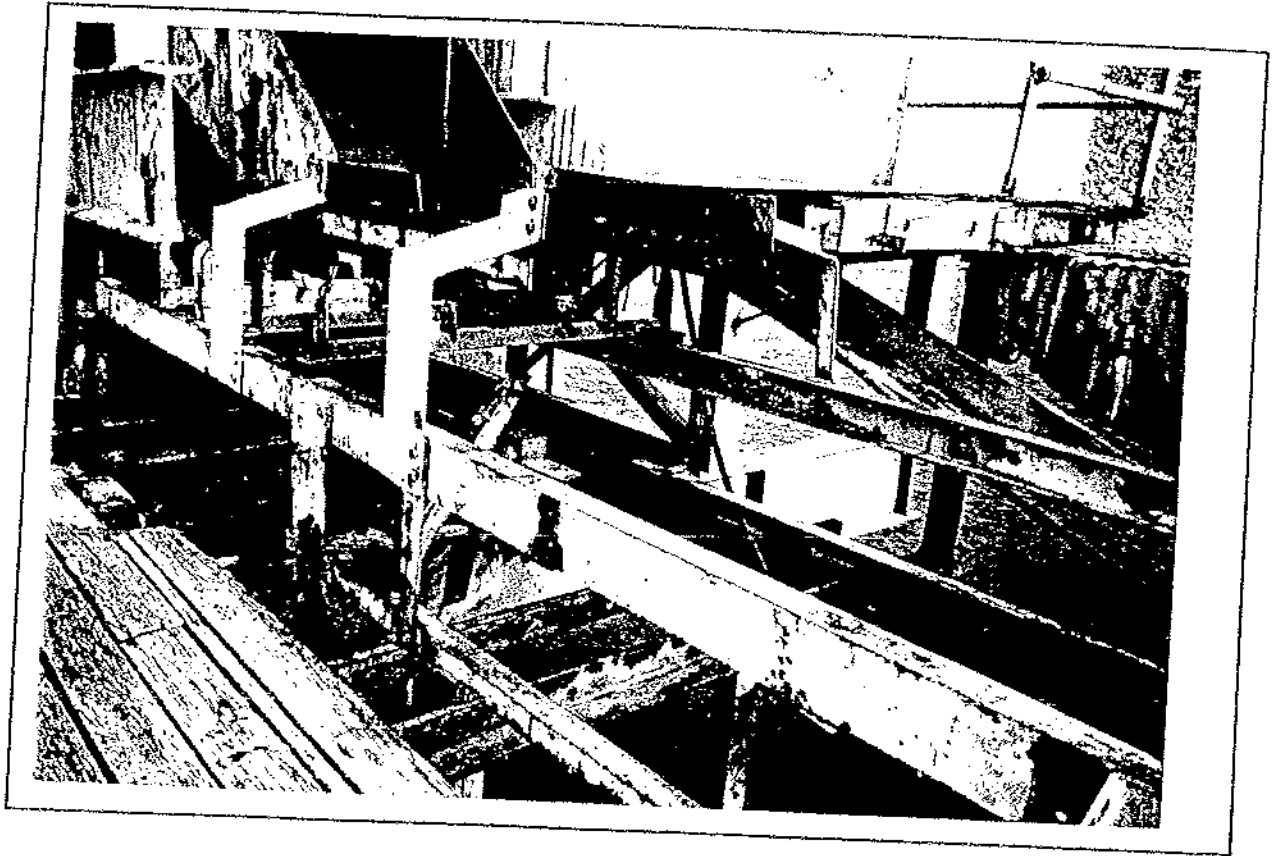
15. Steel piles at crosshead at Bent 38

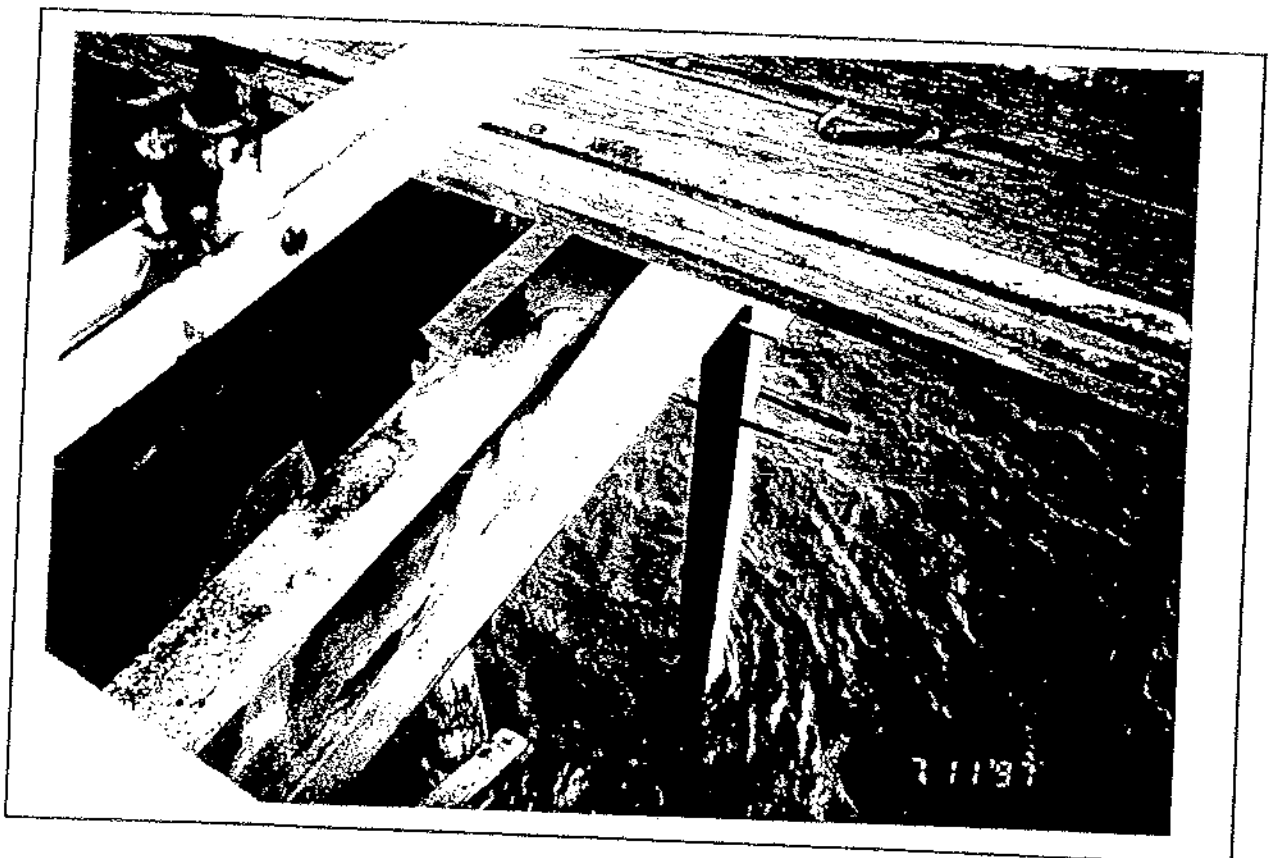
16. Steel piles at crosshead at Bent 48

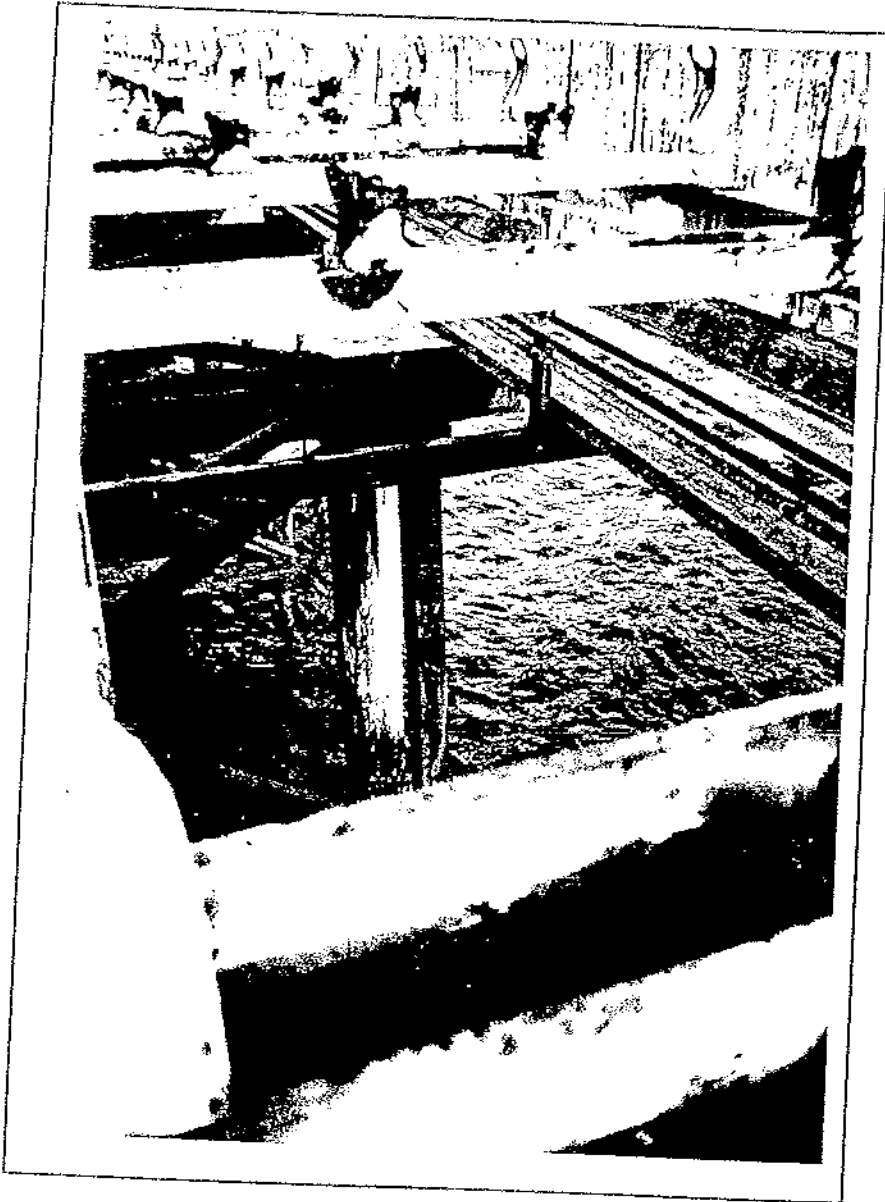
17. Steel pile at Bent 70

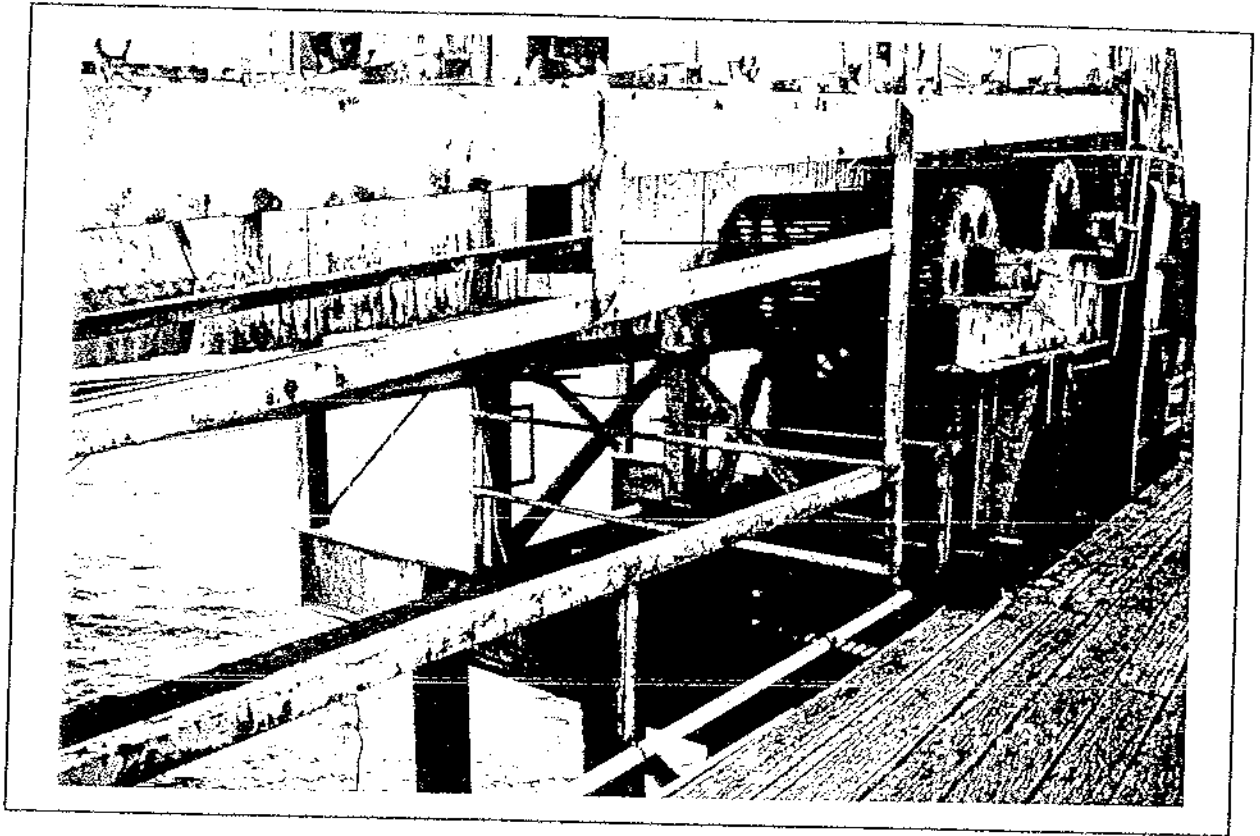
22. Steel piles and crossheads at Bent 79 and 80

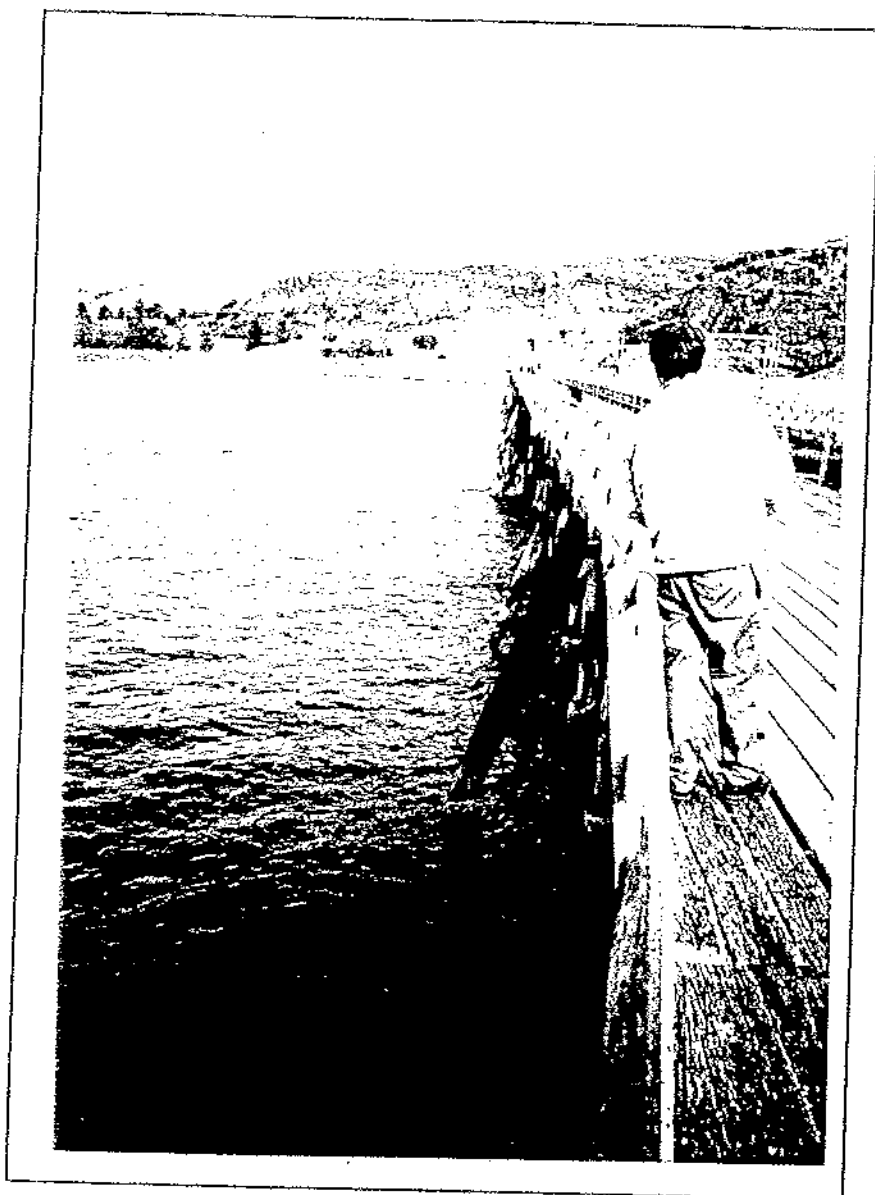
23. Raking steel pile at Bent 76

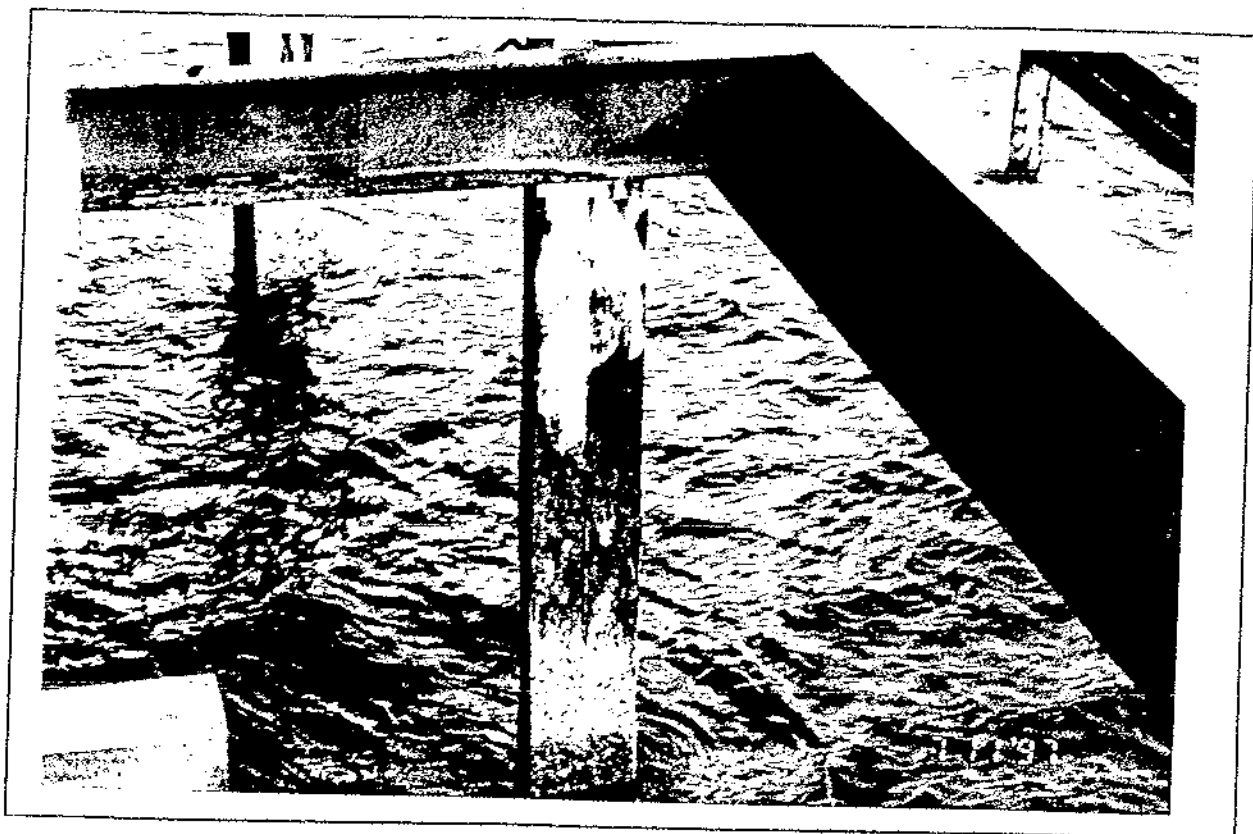
26. Tee head steel piles peeling off at 1 m above sea level

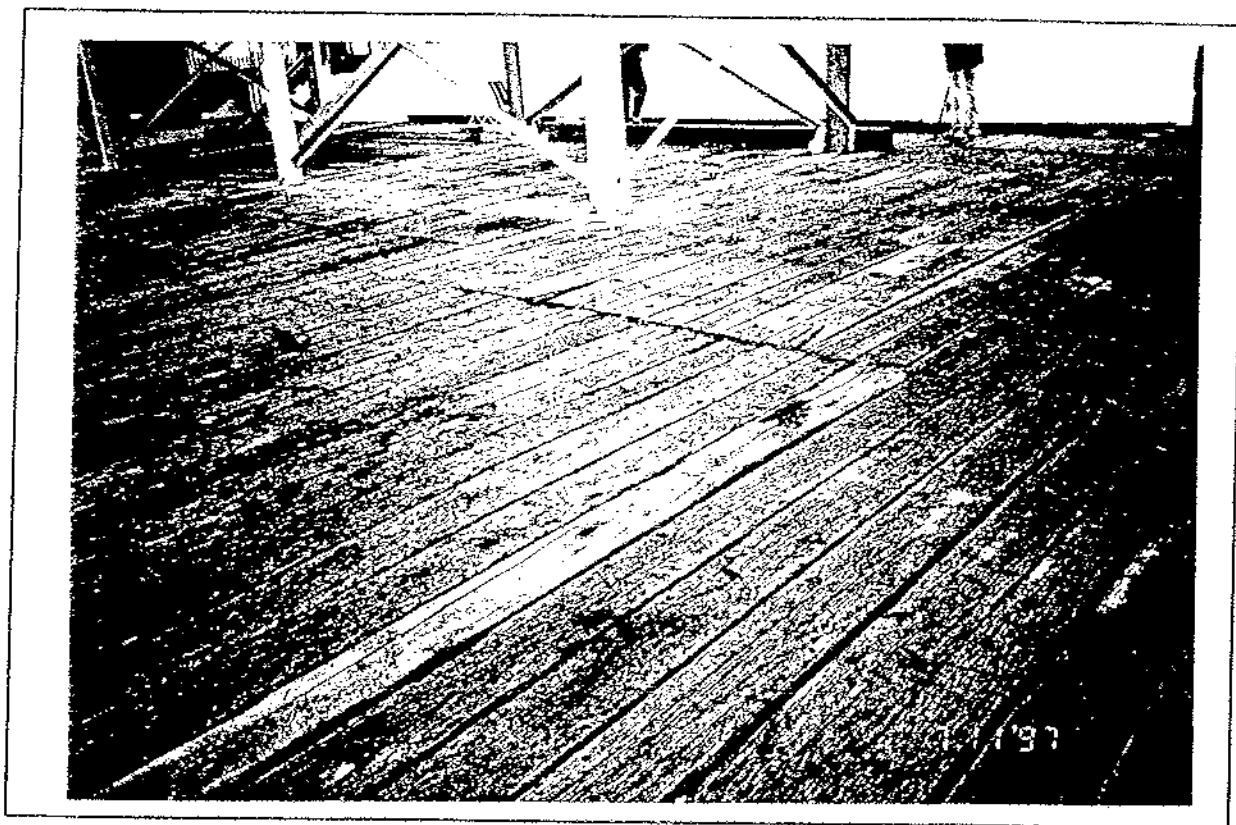
28. Deck at Tee head

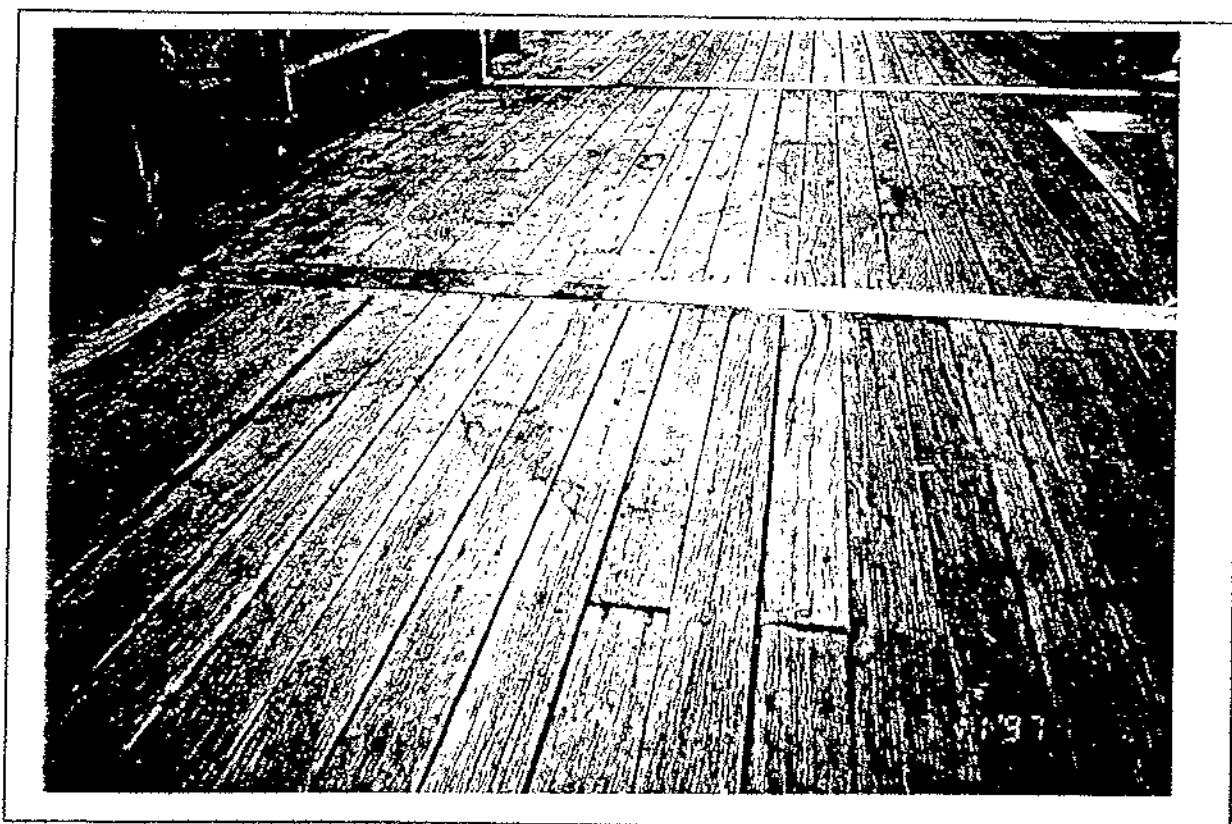
29. Deck beyond Bent 81

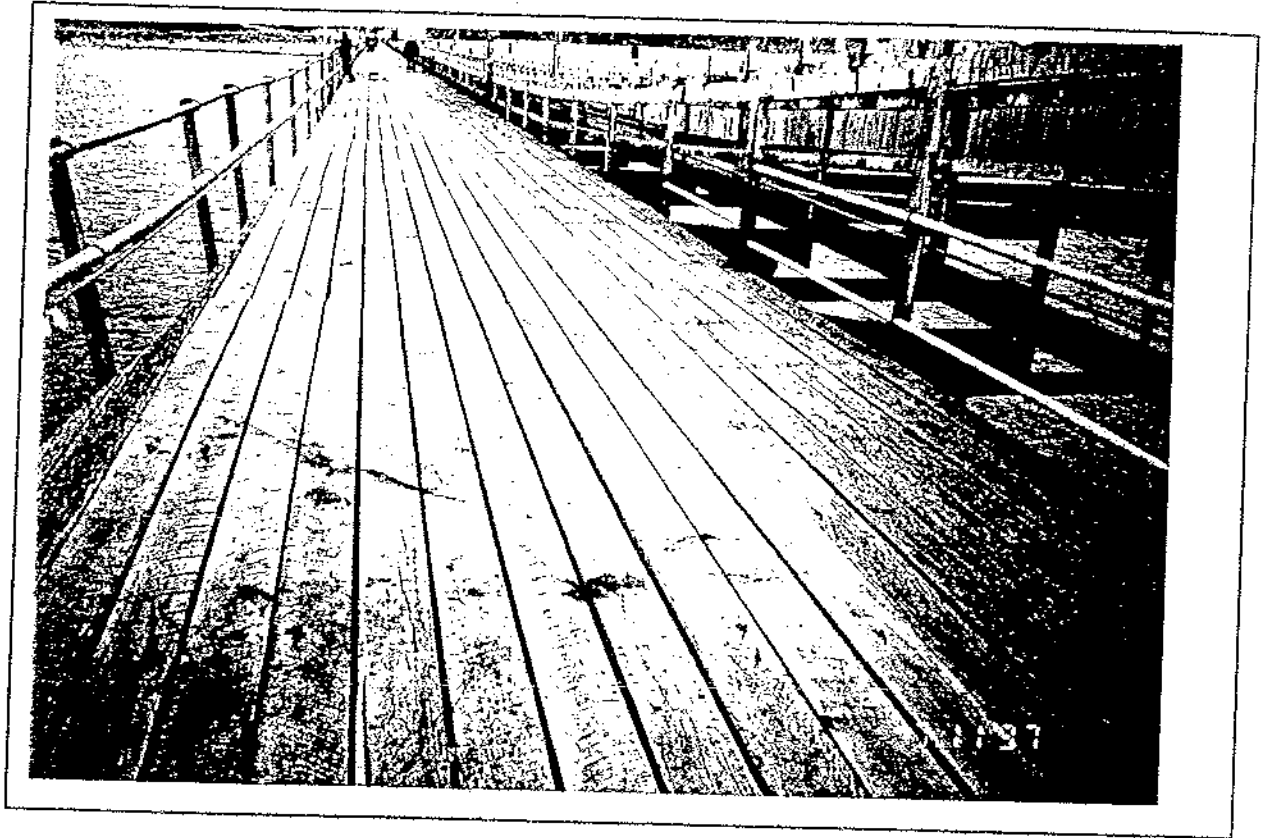
30. Deck between Motor Room Nos. 2 and 3
