RAPID BAY JETTY  
STRUCTURAL STATUS 1987

CIVIL ENGINEERING DIVISION

Report by Lee Warneke - Snr. Tech. Of

RAPID BAY JETTY  
STRUCTURAL STATUS 1987  
TABLE OF CONTENTS

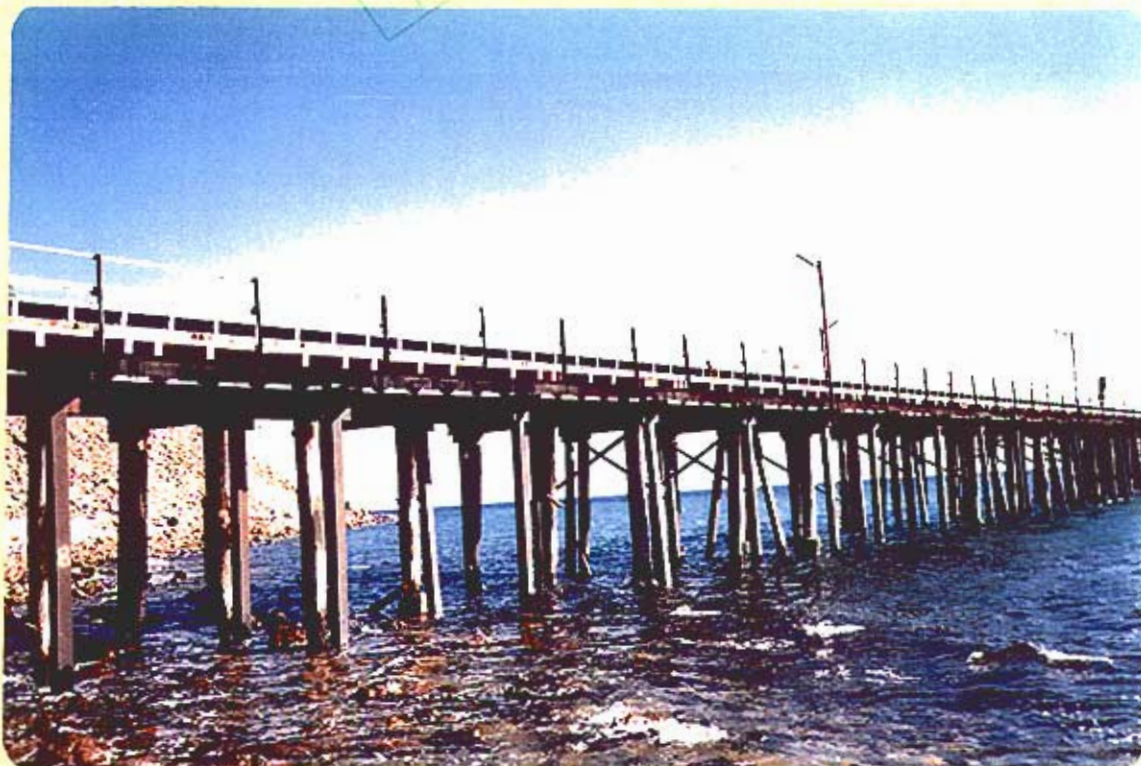
North side of Jetty. Note bent 8 & 10 on steel piles  
(over)

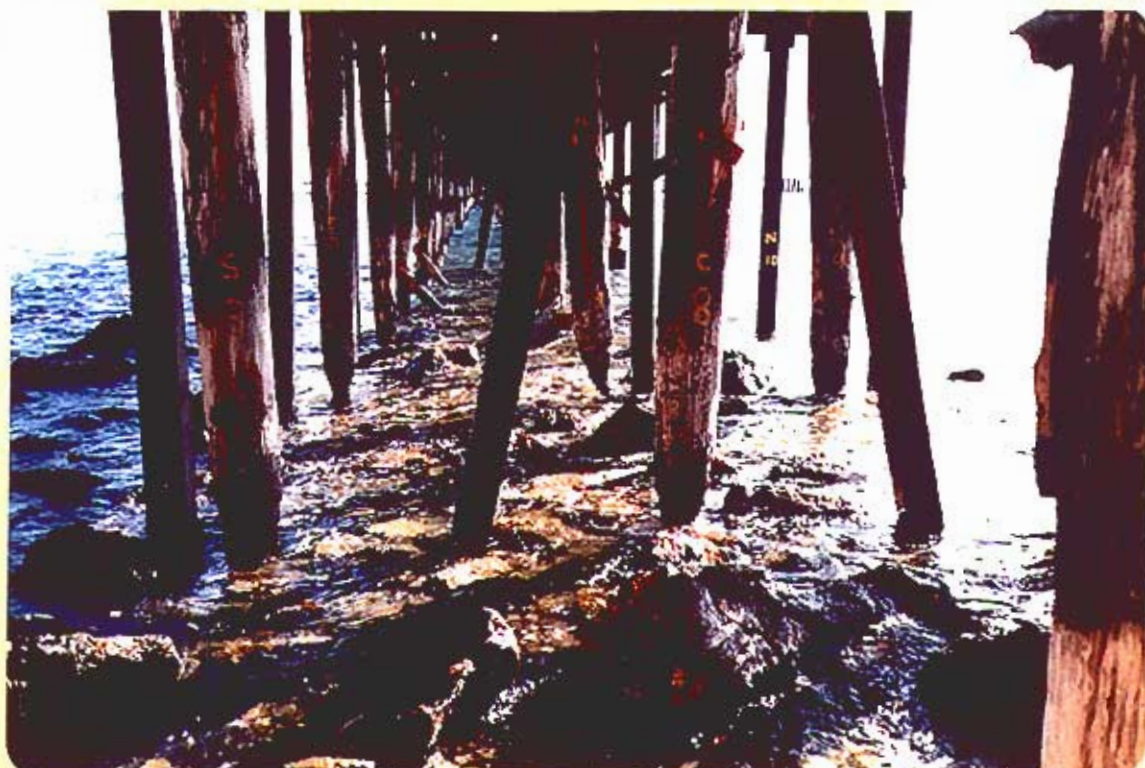
The cross bracing and waling for the piles has corroded away at most bents. The condition of what remains could only be described as useless or of very limited useful life. The new double raker piles at each 5th bent replaces the need for these members.

Piles of Approach Jetty. Note bent Nos & corroded crossbracing.

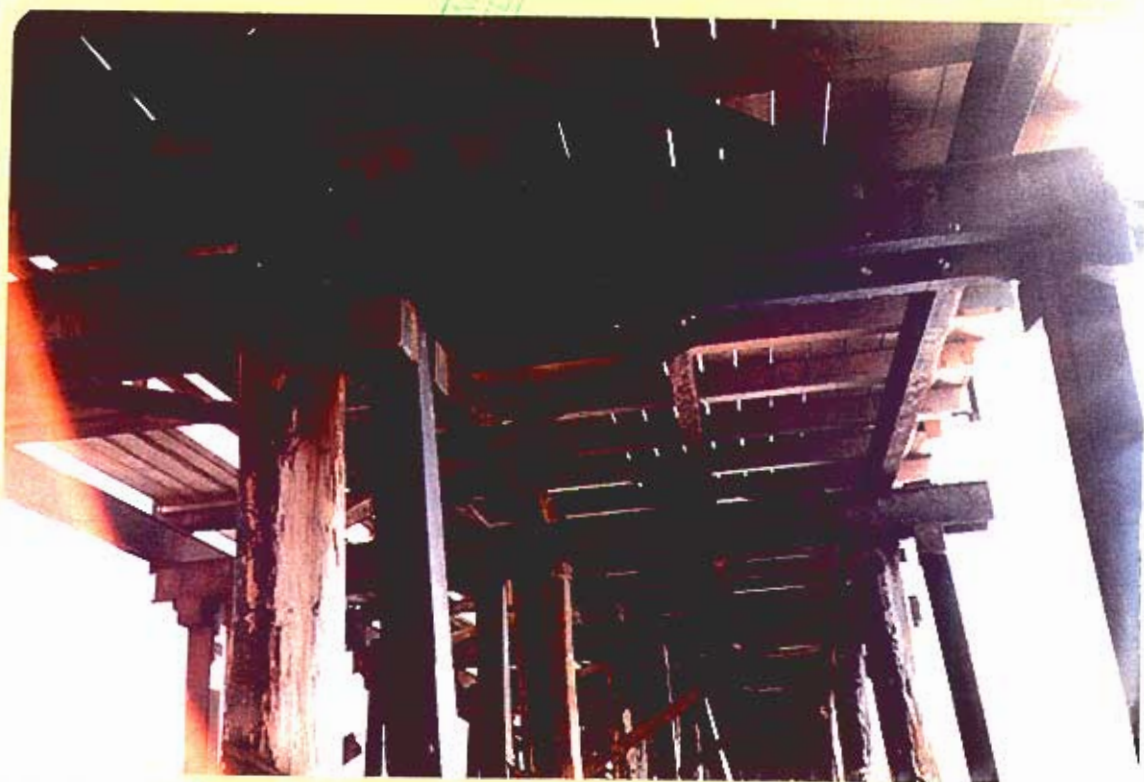
Bent 10 - last one grit blasted & painted. Note condition of bent 11 behind. Deck new.

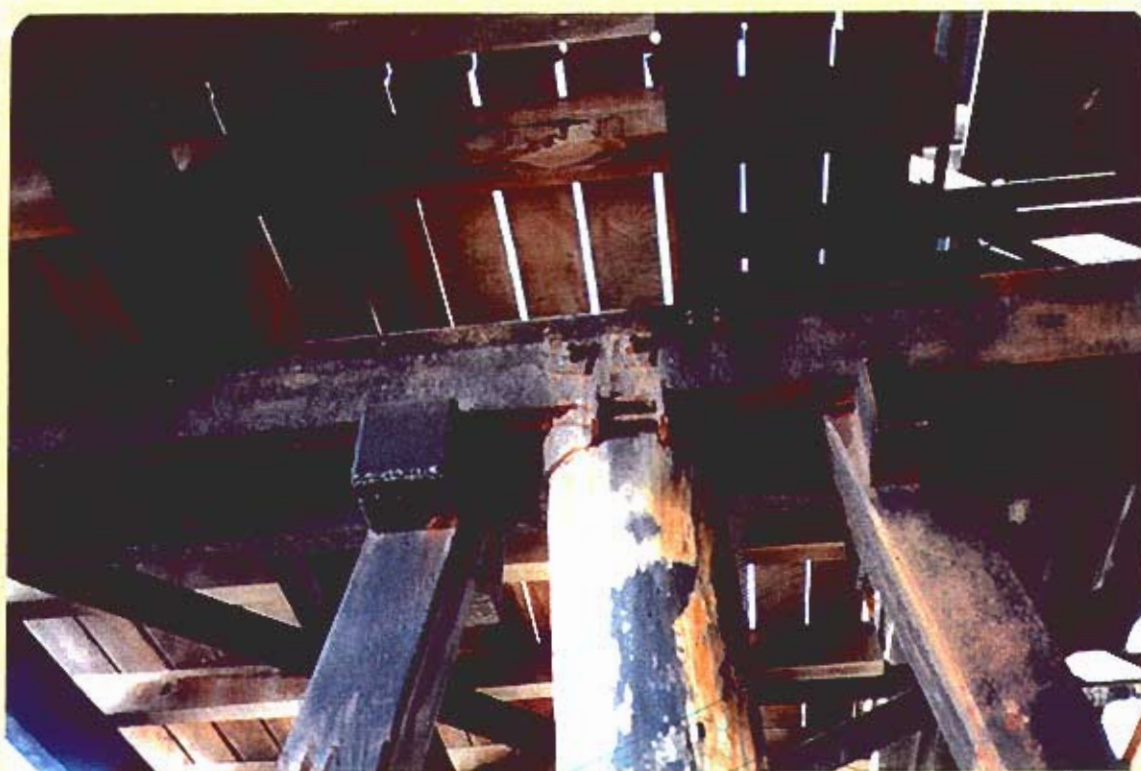
Bent 8 - Double raker piles crosshead support brackets

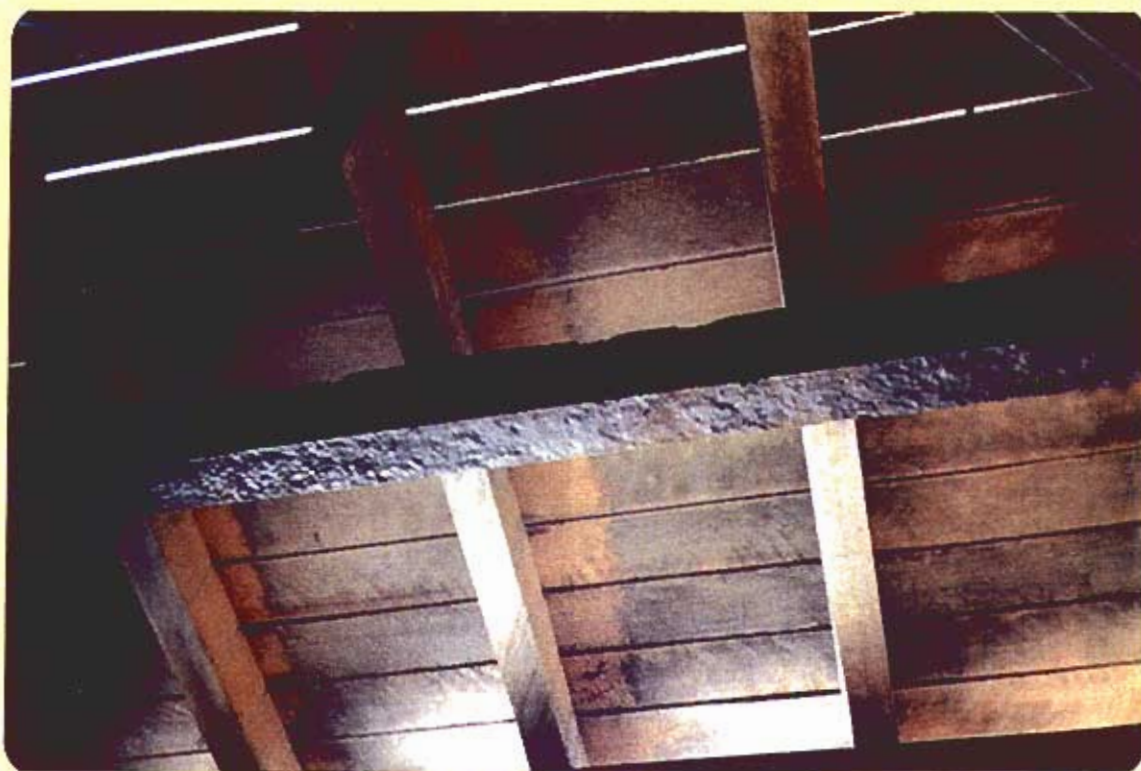
Girder - Grit blasted and painted April 1986

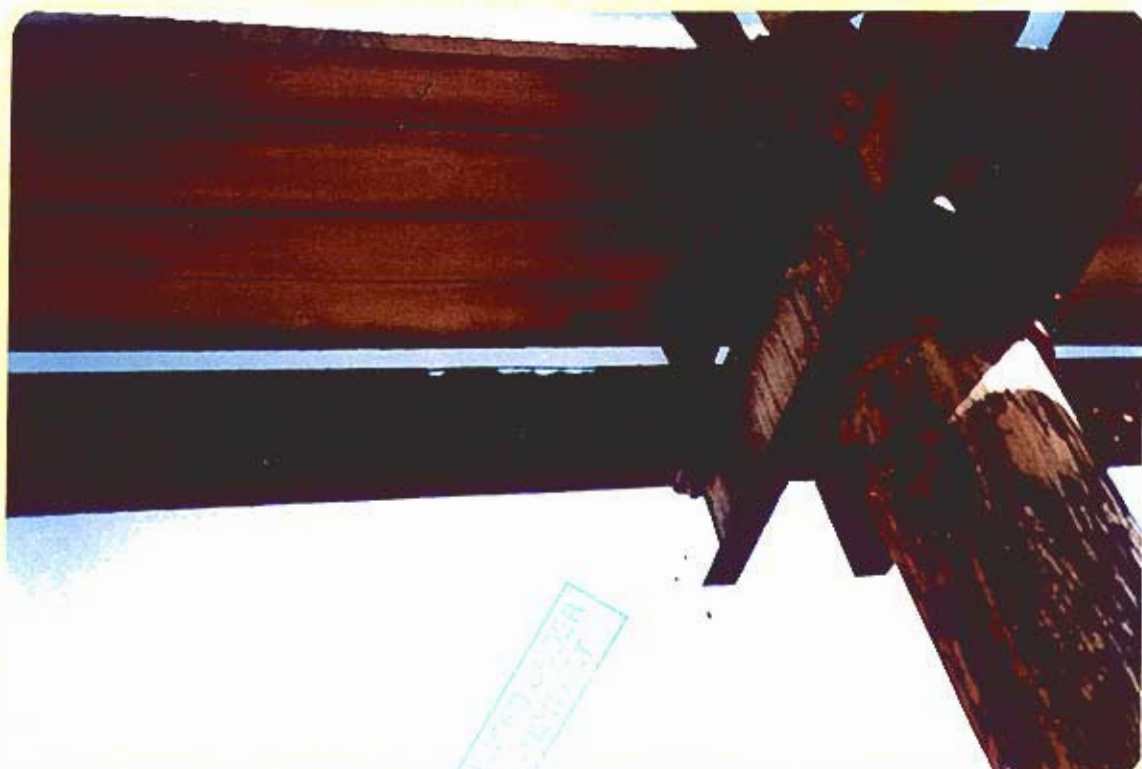
The sub-strata steelwork has been grit blasted and protected with tarset. However this work has revealed serious degradation of the steel work and it appears that the coating is incomplete or not applied correctly. Many areas are displaying recent corrosion through the thinly applied coating. (See photos).

Girder at bent 6 (approx). Note rusted through flanges

The beams that have corroded to such a state that holes have appeared in members-require replacement. Also areas of obvious thin coating require remedial treatment in the form of grit blasting to class 2½ condition and painting with 2 coats of tarset to a total thickness of 450u.

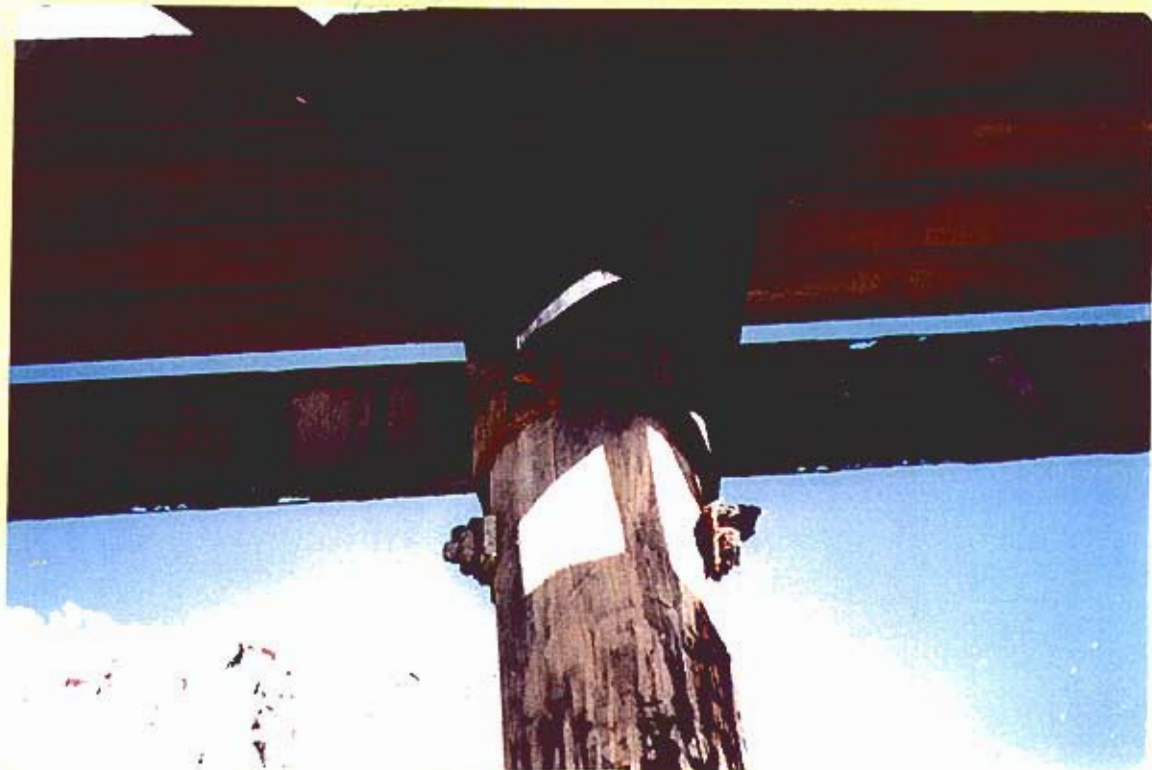
bent 5 (approx) as above.

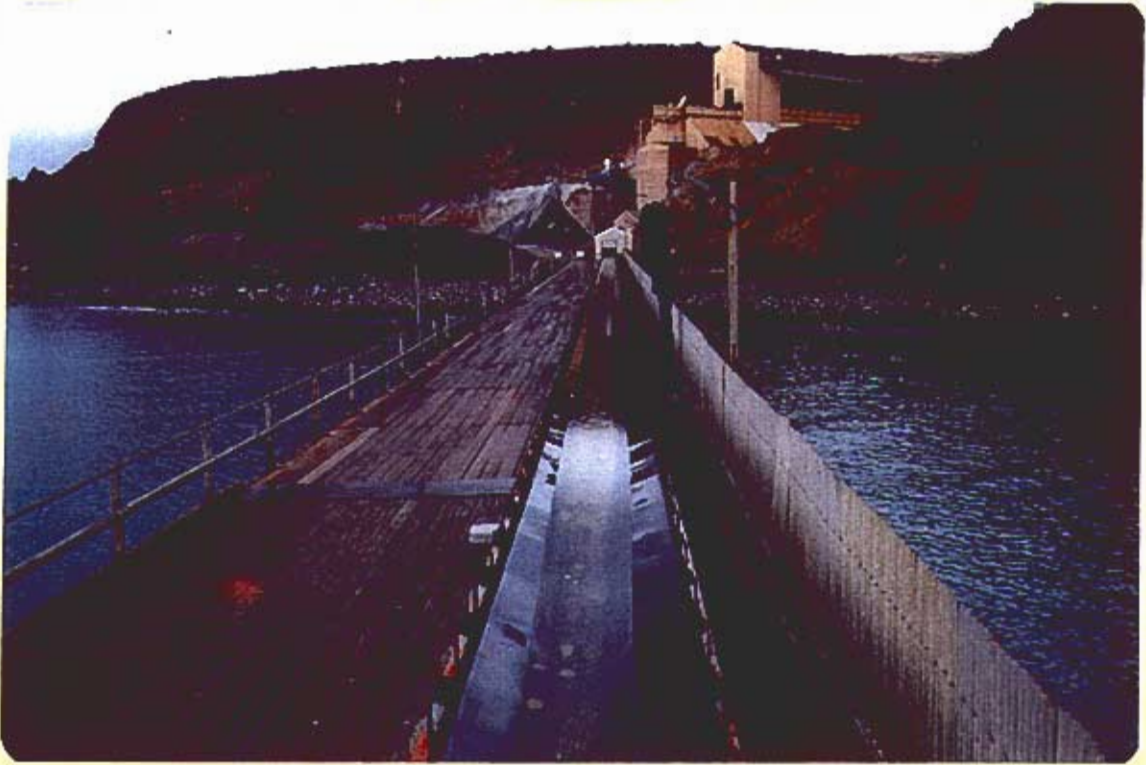
Redecking Progress - to bent 26. Note pile hammer stored on top of last pile driven.

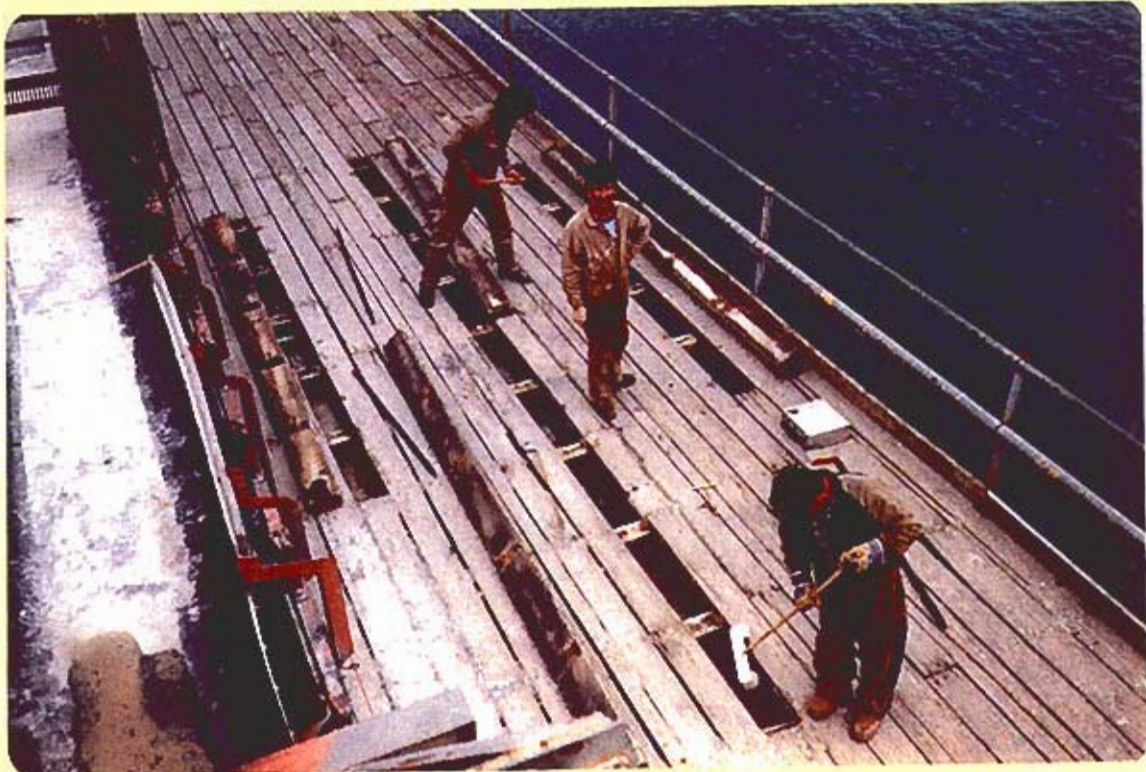
Test procedure involved removing planks above girders, bents 39 - 40.

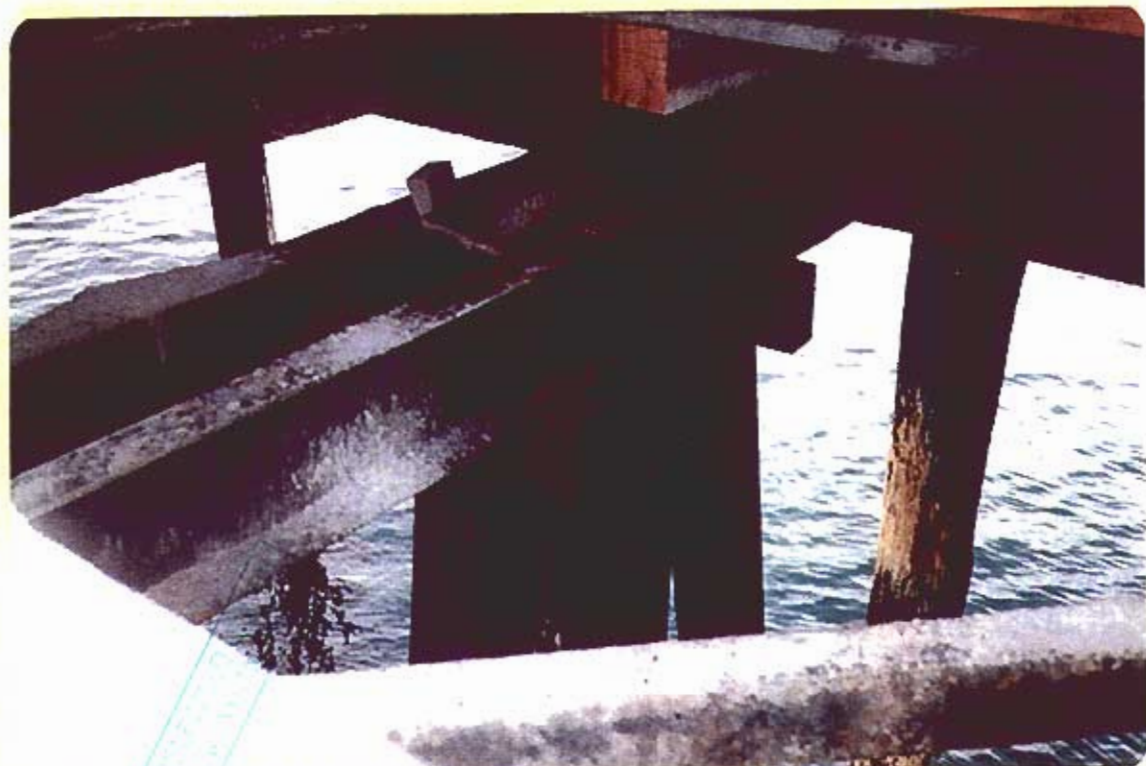
Crosshead support brackets. Note condition of girder etc

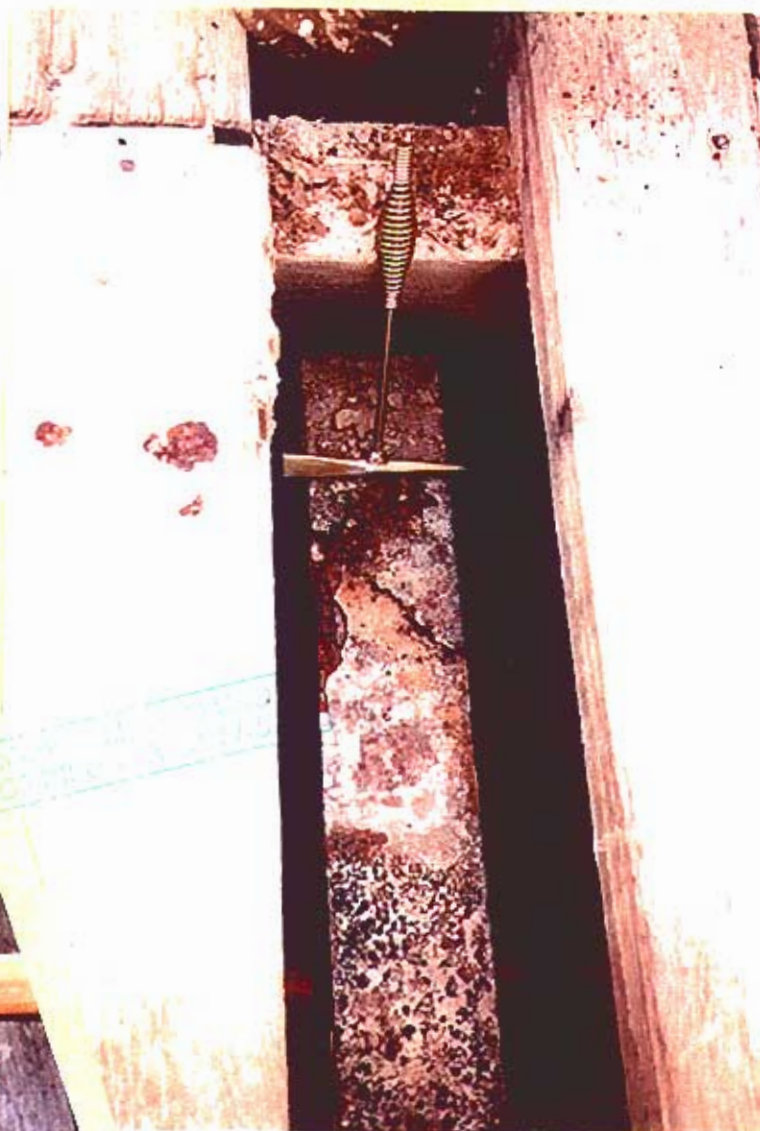
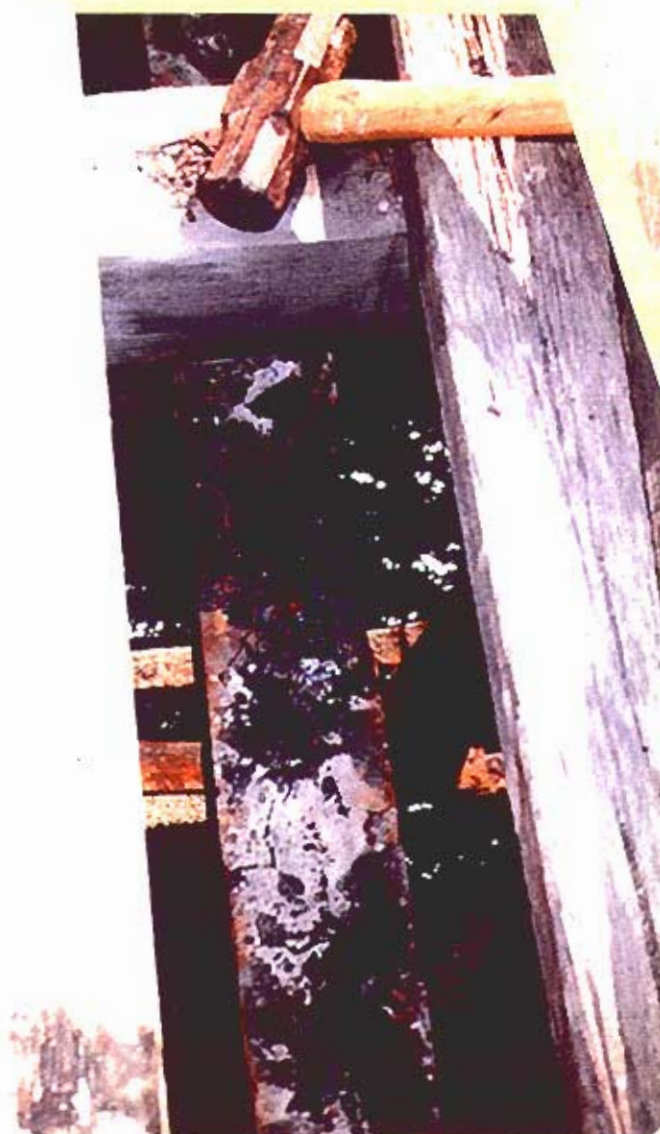
Girder before hammering

Thick rust on top of girder  
note paint on top of rust.

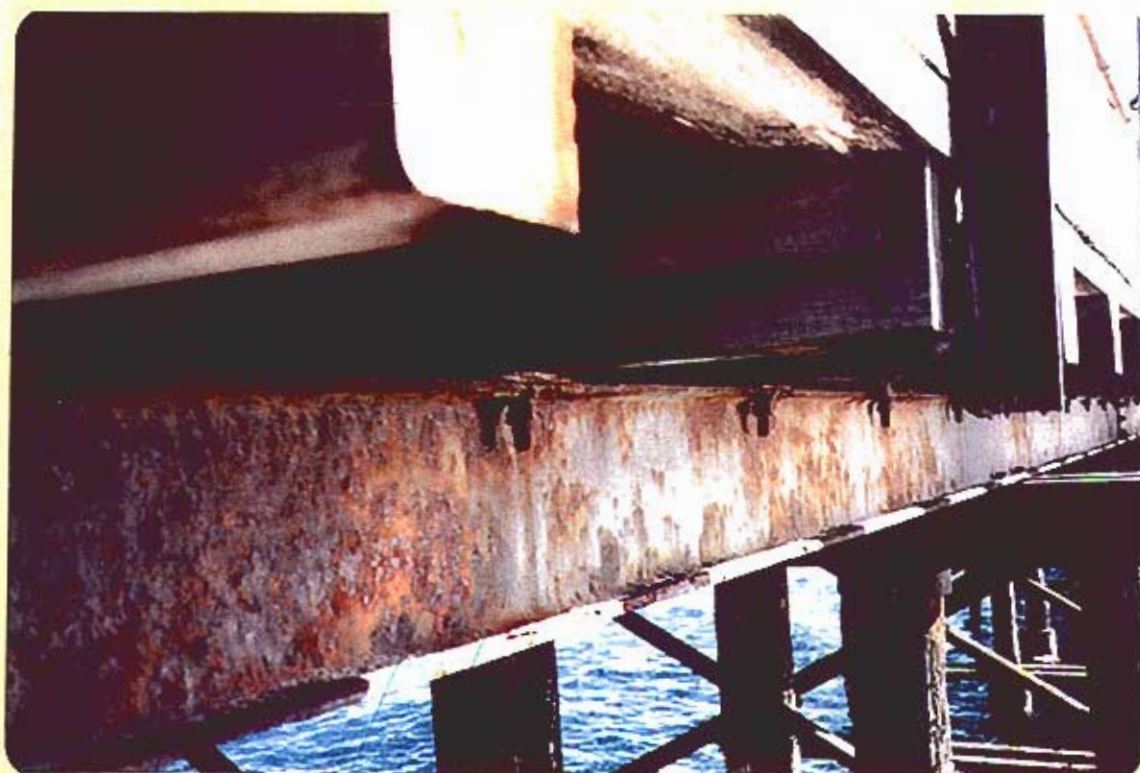
East Side Girder 'G1' - See Cals.

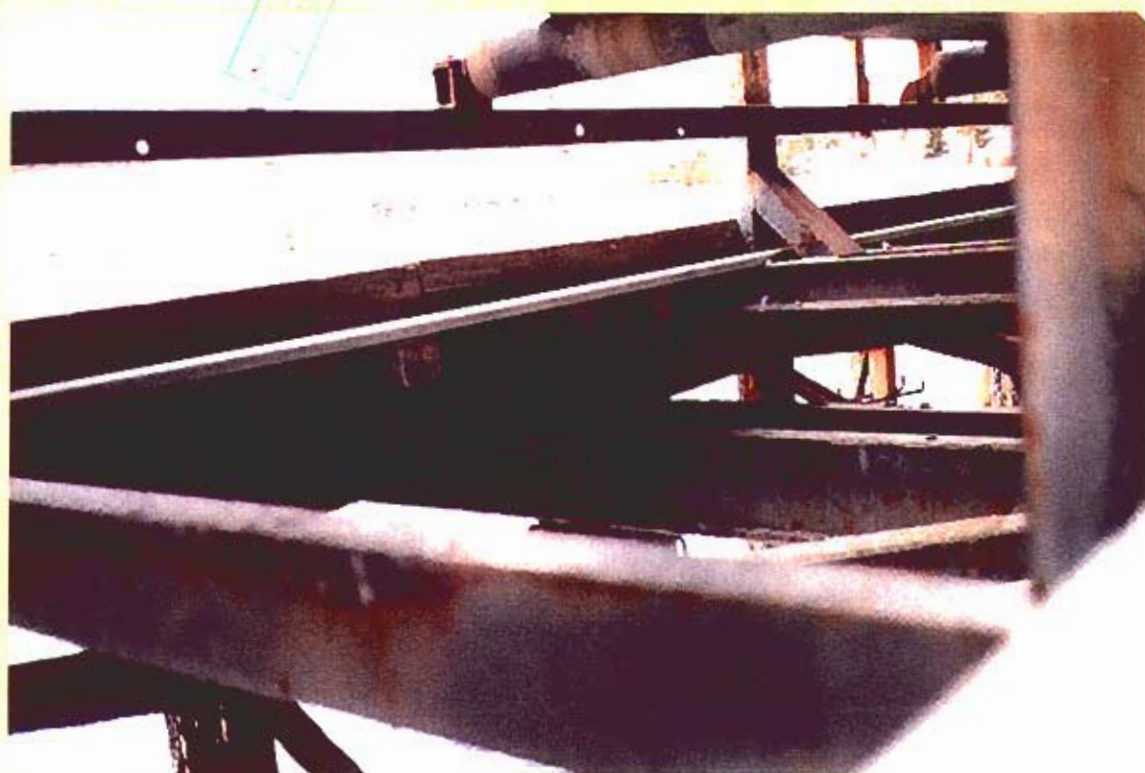
Central Girder 'G3' - See Cals.

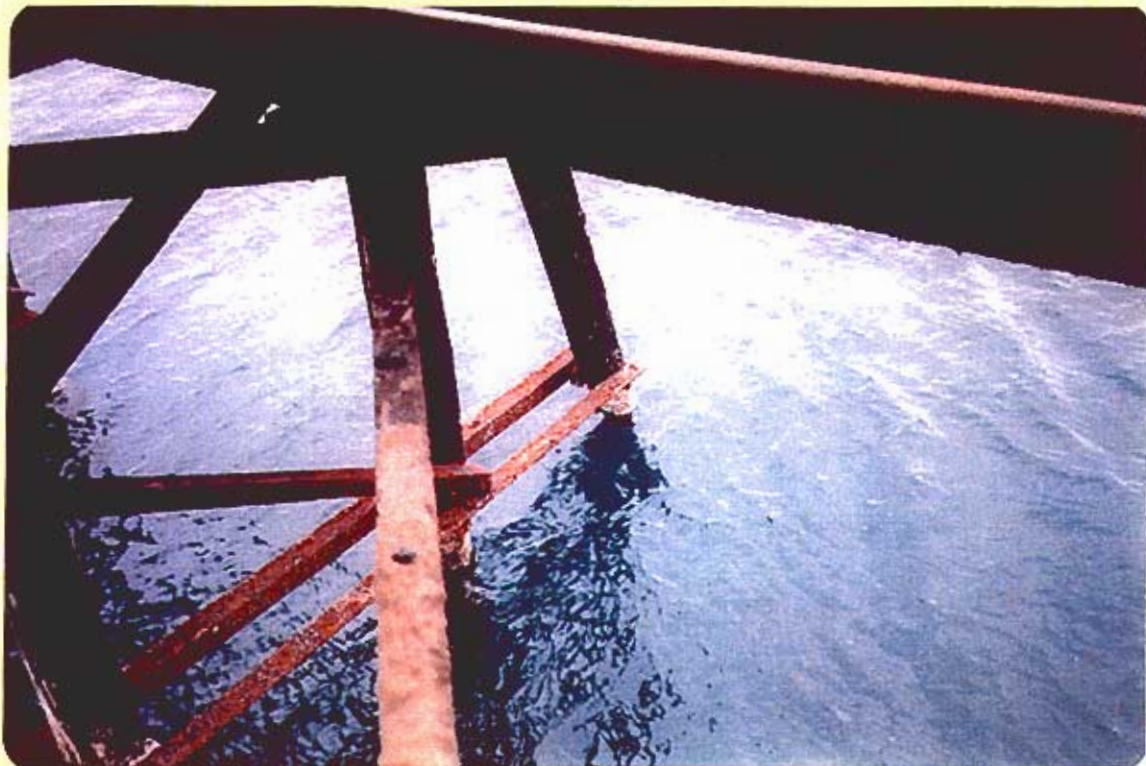
Typical Waling & Crossbracing (where it hasn't rusted away note. wooden raker pile eaten off at water level.

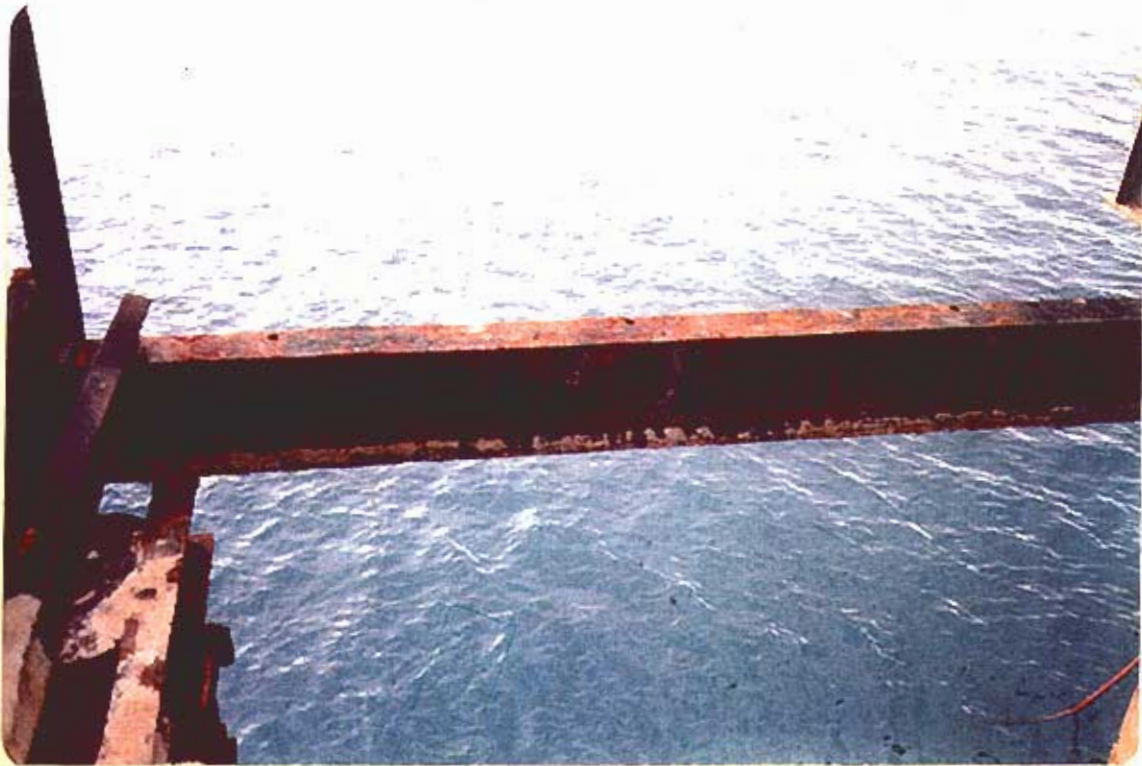
The main girder G4 <sup>at</sup> is in the best condition, it appears to have been replaced/sometime. The coating is grey, of galv. paint origin also occasionally faded terra cotta coloured coating - suspect faded primer paint. Frequent minor outbreaks of corrosion indicate treatment of these girders is required. However, replacement is not required.

West Side Girder (under conveyor) G4 bent 76.

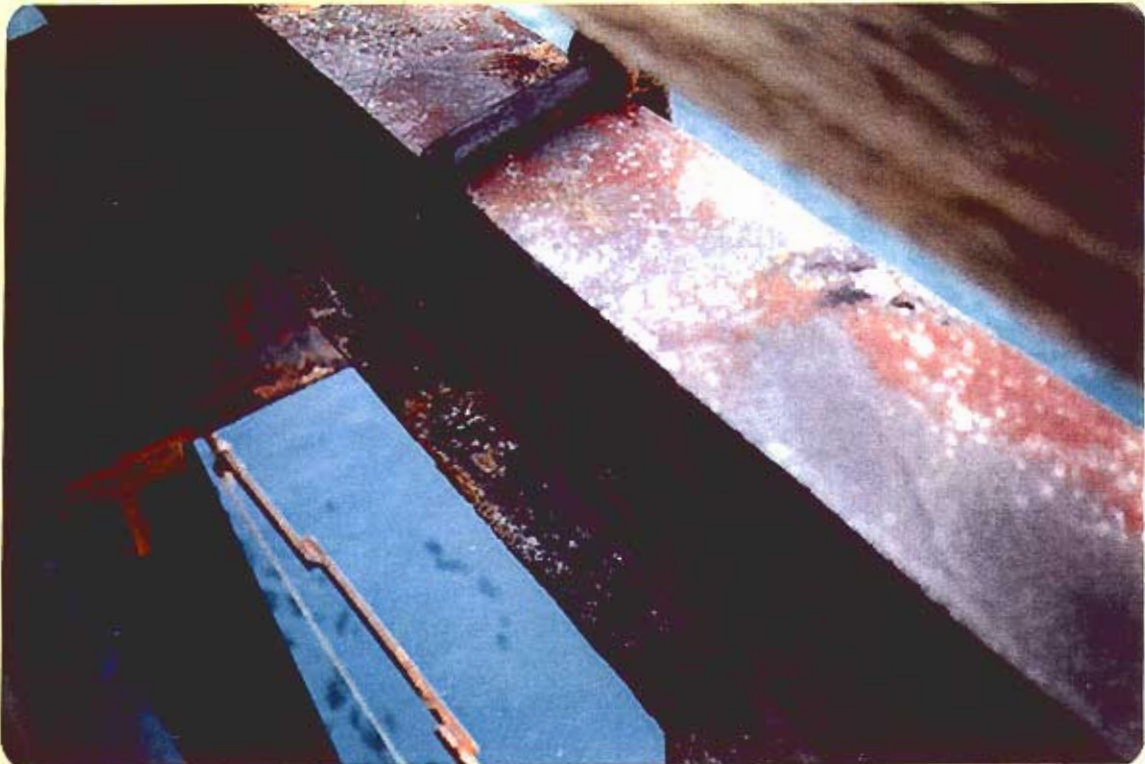
The main west side girder (G4) <sup>See P.6</sup> under the conveyor has been replaced in the past; after Bent 18. the coating on this girder is different to the main deck girders - being of grey (dimet) appearance as compared to black (tarset) appearance. This south side girder is of the standard RSJ type of 35lb/ft, whereas the other girders are the thickened web type of 40.53lb/ft. Although appearing generally in better condition than the main deck girders local areas of these south side girders have corroded significantly requiring remedial cleaning and painting.

West Girder G4. (Bent 24 approx)

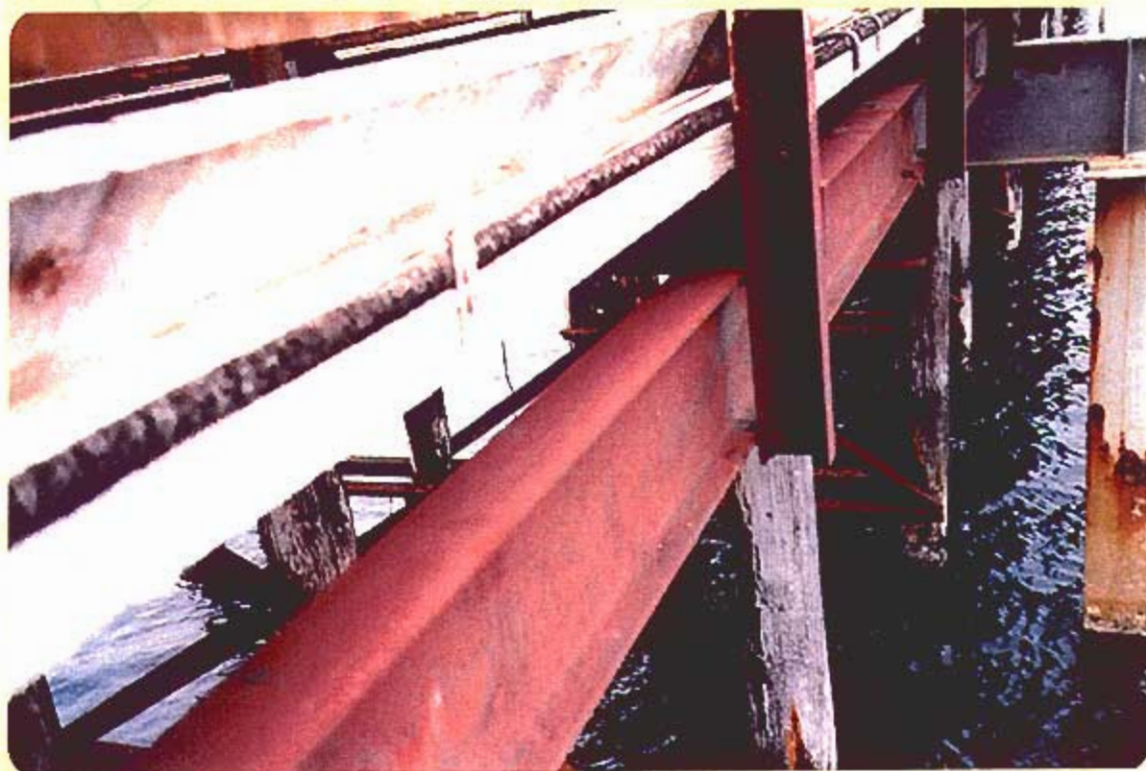
West Side Girder - different coating

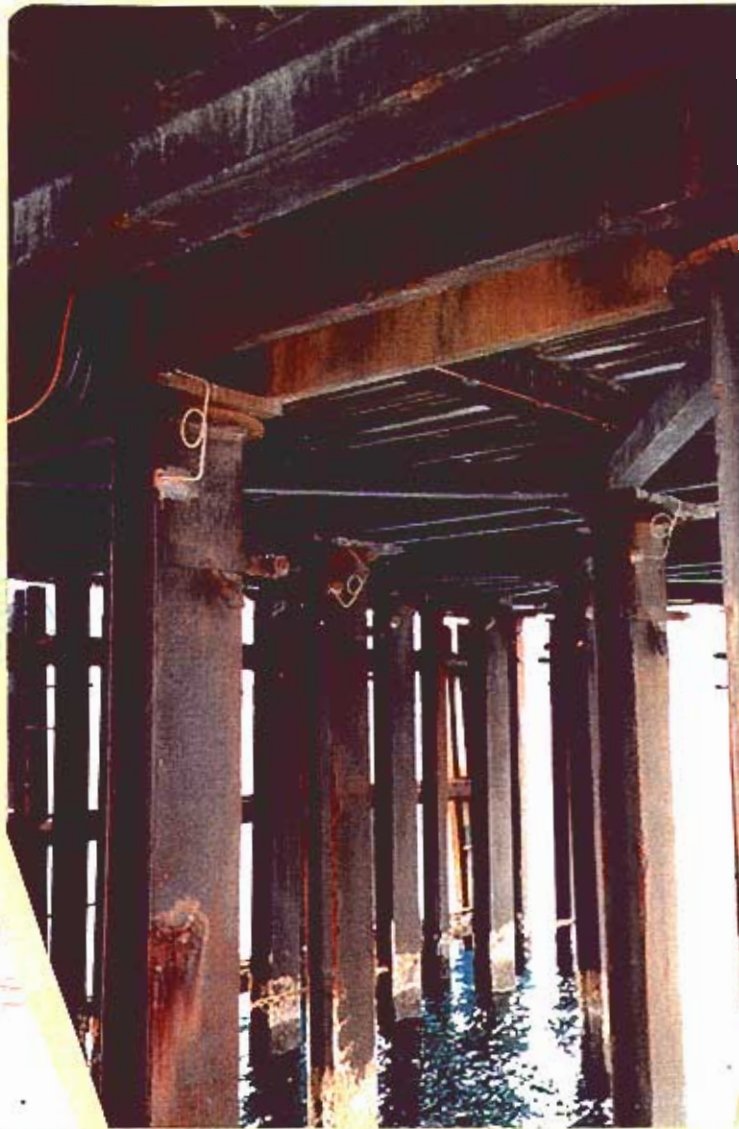
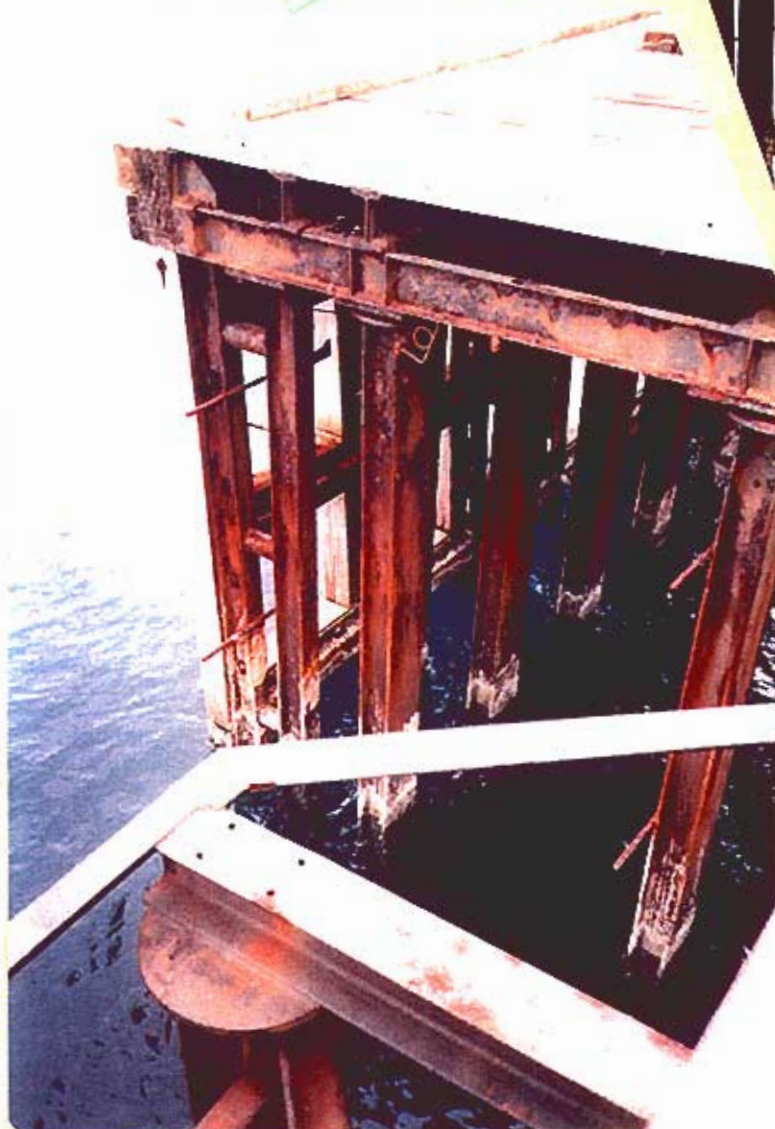
As the photos show, areas of the 'T' head steel work are corrosively as variable as the older steel work with isolated areas of corrosion well underway while others are faultless.

Worst Area of Corrosion  
of 'T' head noted.

The 'T' head of the Rapid Bay Jetty was re-built in 1968. The general condition is obviously much better than the older original substrate steel work and piling. Remedial work should be confined to grit-blasting and painting of this steel work. The cathodic protection of the piles has recently been re-done and should require only minor maintenance in the near future.

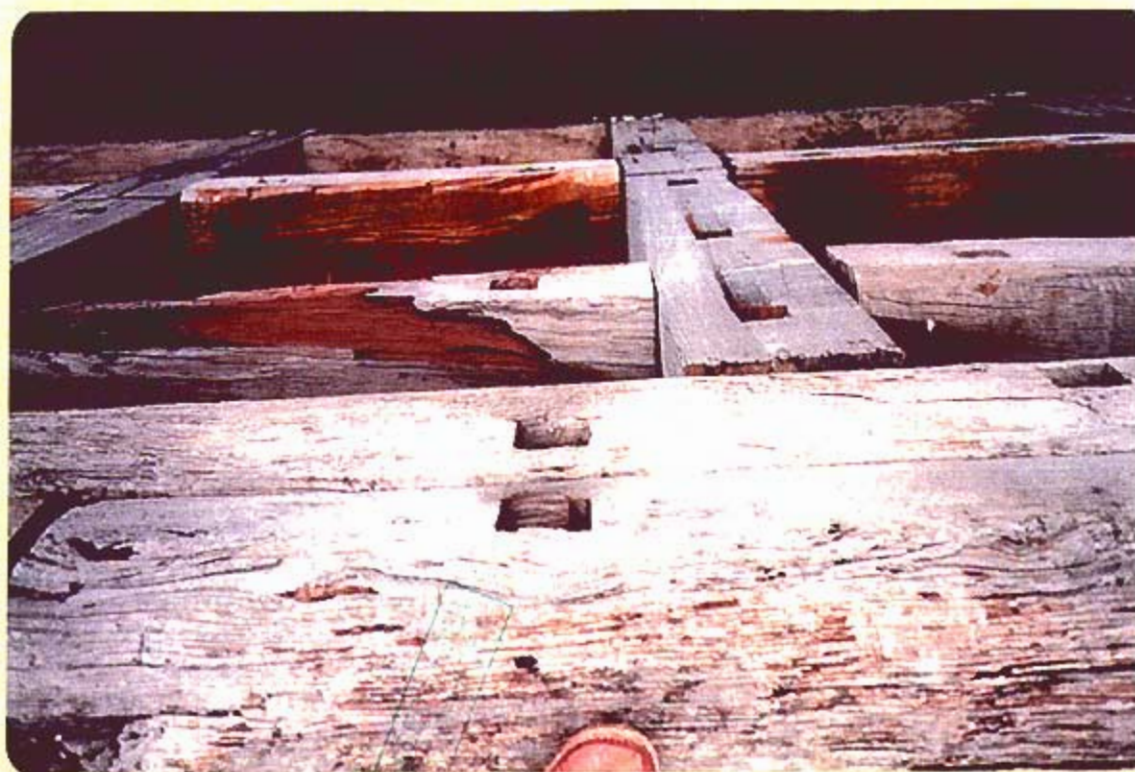
This is regularly damaged and is subject to an approved reconstruction program with new sheeting to protect the timber work.

'T'-Head Fendering - Damaged .

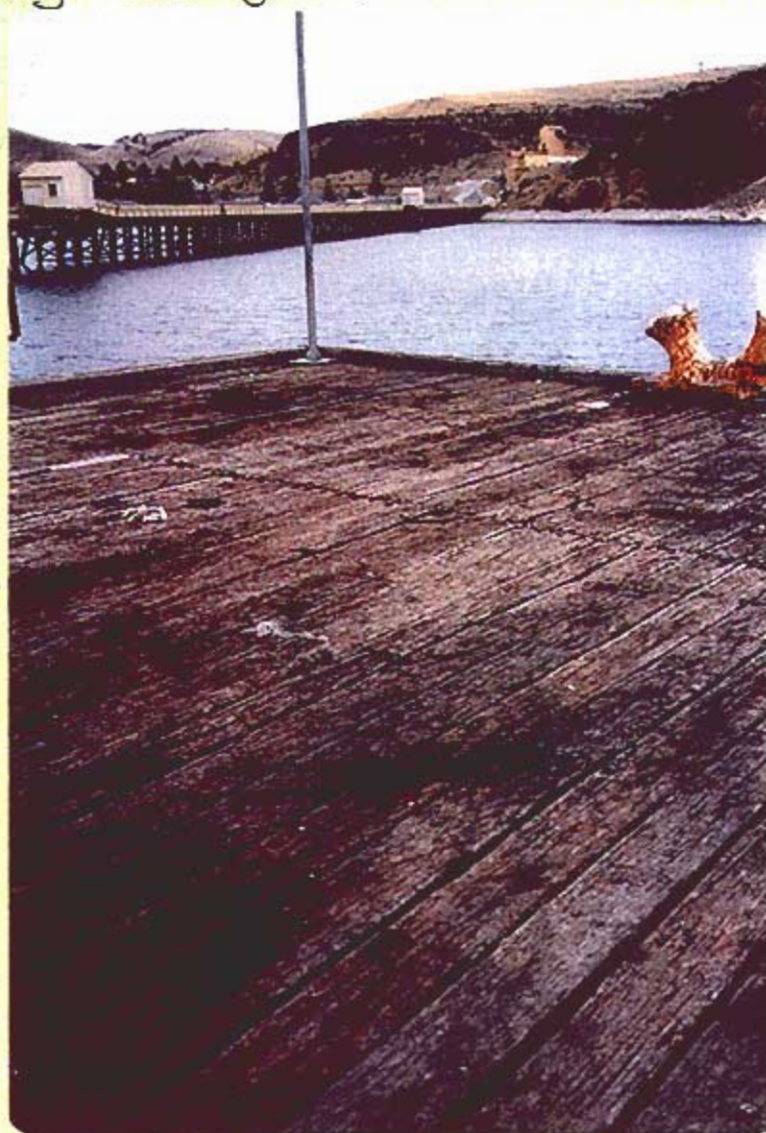
The deck of several of the 'T' head dolphins is however in a poor state and requires replacement as does the timber walkways which access these dolphins. *Non-slip surfacing required.*

Deck of 'T'-Head  
Dolphin  
(Typical)
