RAPID BAY JETTY

STRUCTURAL CONDITION REPORT

FINAL REPORT

December 2004

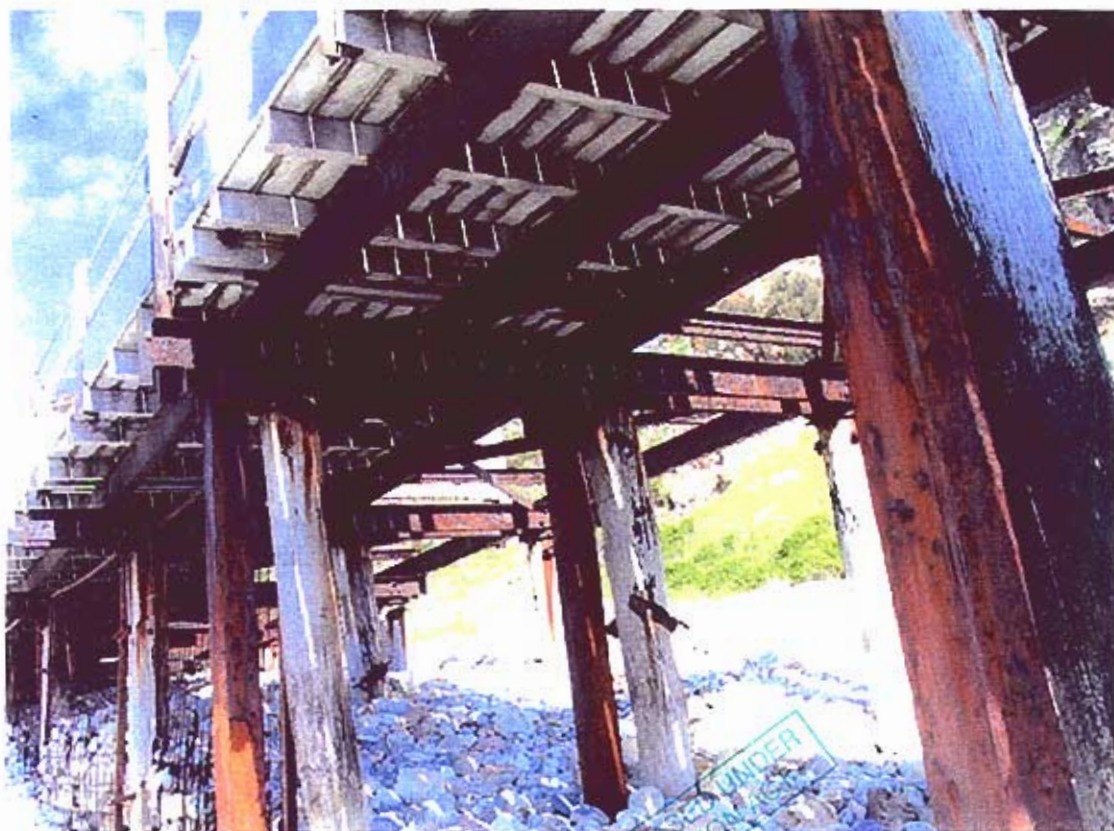
Photo 2 – General Underside of Approach Jetty (new steel piles adjacent to existing timber piles)

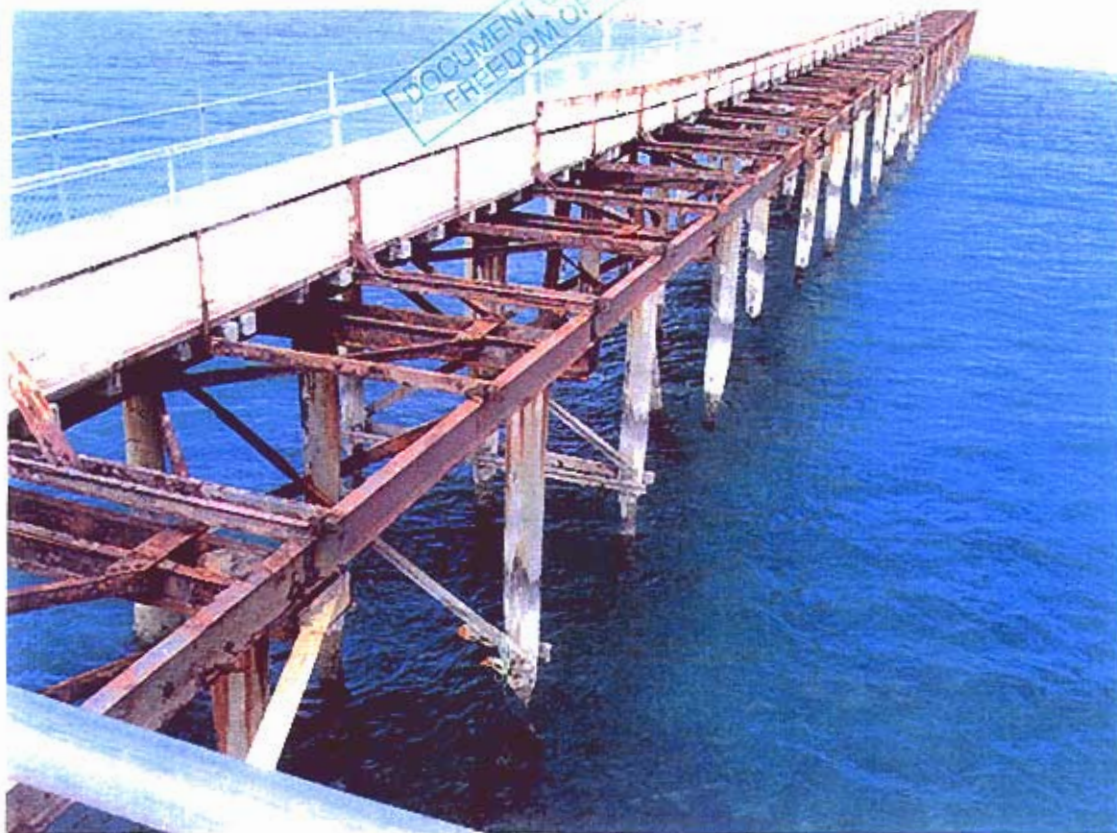
The remaining girder, on the western side, previously supported the conveyor equipment that was removed in the late 1990's (photo 3). The girders are 2 span continuous, that is spanning across intermediate bents, and are joined to the girders in the adjoining spans with bolted splice plates on the webs (photo 4). The original drawings indicate that the girders and channels are thickened sections indicating a level of corrosion allowance in the design.

Photo 3 – Western Side of Jetty Looking South

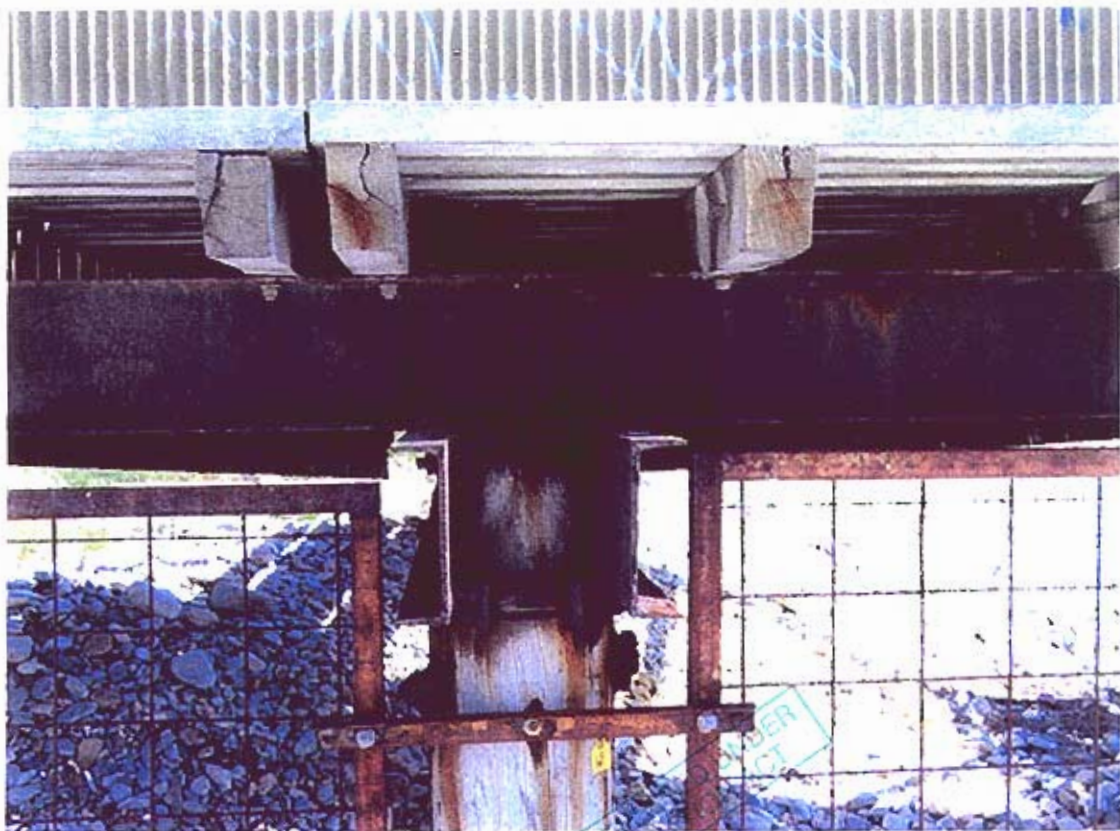
Photo 4 – Typical Detail at Bent at Ends of Girders

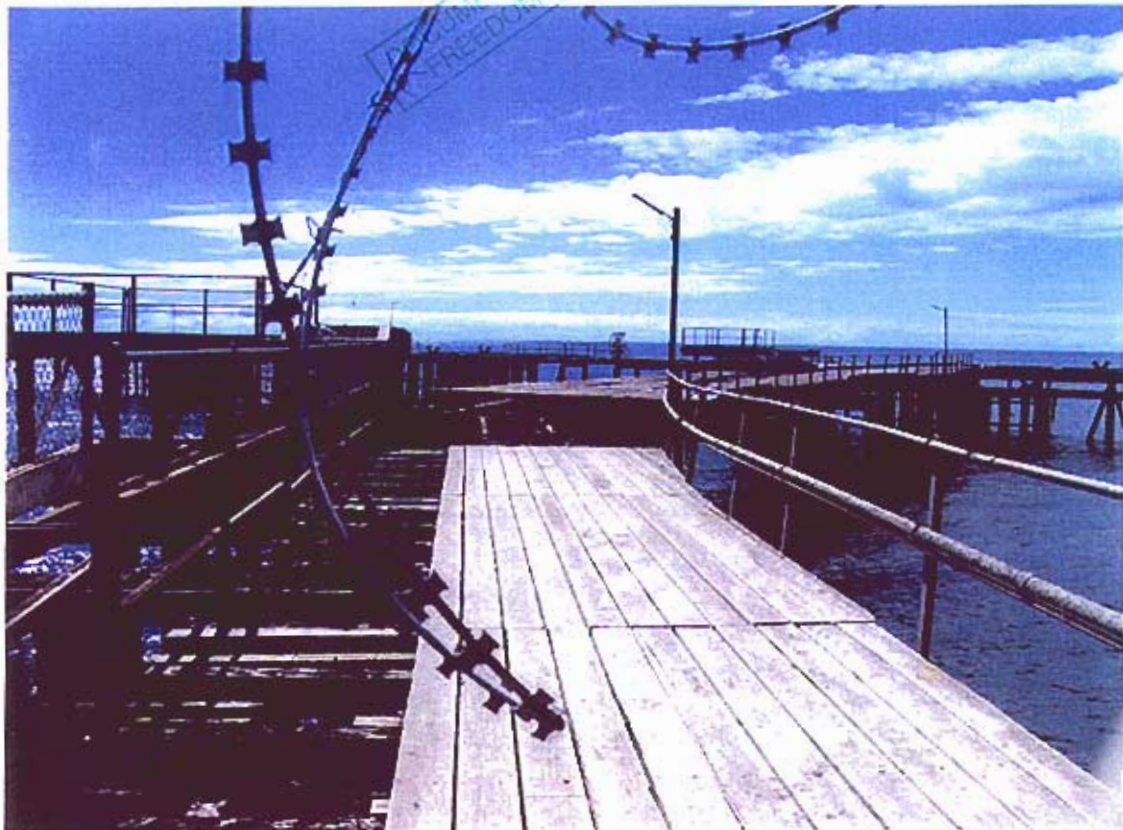
On the approach jetty, all piles between bents 7 and 26 have been replaced with steel box piles. A number of failed timber piles between bents 27 and 79 have also been replaced by either steel H piles or steel box piles. The timber decking on the T-Head section is in a dilapidated state resulting in this section being closed to the public in June 2003. This was achieved by the installation of a large security fence with appropriate signage at bent 75 as well as removal of sections of decking immediately past this point to further discourage would-be trespassers (photo 5)

Photo 5 – T-head Section With Decking Removed
